**SCOPE OF WORKS
&
TENDER DOCUMENT**

The Owners - Strata Plan

Remedial works to Common Property
and within individual unit areas

17th September 2010

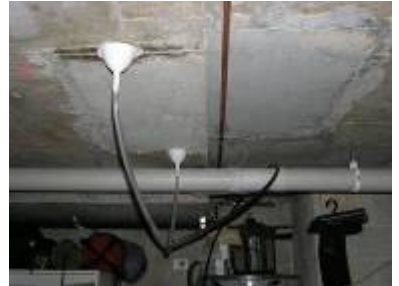
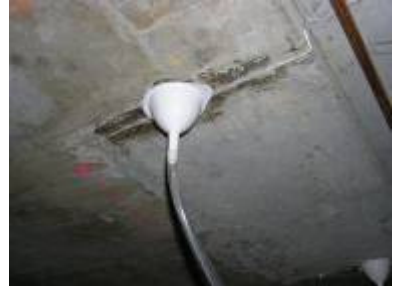
Item No	Item Description, Position & Cause	Scope of Works Required	Photograph If Necessary Or Applicable
	COMMON PROPERTY AREAS		
	GARAGE		
1	<p>Description: A water leak from the soffit area over car parking space of Unit 6 is evident.</p> <p>The location of the leak has calcium hydroxide laden water dripping onto cars utilising the parking space.</p> <p>This leak renders the designated parking space as not being fit for purpose due to the damage that the mineral laden water will do any cars paintwork.</p> <p>Presently the owner of Unit 6 has attempted to catch and re-direct the leak himself.</p> <p>Cause: The actual cause of the leak is unable to be determined without destructive exploratory works, however it is considered to be due to non collected surface water being able to pass through the slab via small fissures.</p>	<p>Allow to carry out the following works:</p> <ul style="list-style-type: none"> Remove and dispose of the existing water collection system employed Supply and install a suitably folded stainless steel soffit gutter under the area of the current leakage fixed to the underside of the concrete soffit using expanding masonry anchors. The gutter is to be specifically manufactured to the required size and shape. The base of the gutter is to be graded to a single drainage position. A 35mm PVC drainage line is to be fitted and sealed to the new soffit gutter. The drainage line is to be fixed to the soffit by adjustable "dropper" style brackets and then run down the nearest masonry wall section to where it is to be cut no more than 50mm from the floor slab to allow for all collected drainage water to run freely to the floor slab. Make good any original finish affected by the remedial works. Clean up on completion. <p>Performance Requirement</p>

Item No	Item Description, Position & Cause	Scope of Works Required	Photograph If Necessary Or Applicable
		<ul style="list-style-type: none"> The current soffit leak is to be caught and directed away to ground where it will cause the least inconvenience to the garage owner and no longer allow for mineral slat contaminated waters to drip on to cars utilizing the garage space

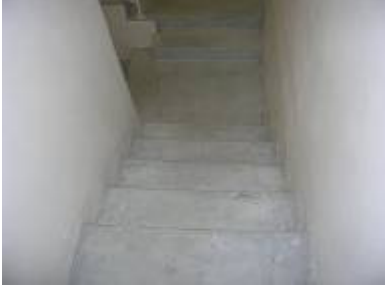
Fire Escape, Eastern		
4	<p>Description: There is no handrail servicing the stairs leading down into the fire escape from the entry foyer servicing Unit 3.</p> <p>The stairs in their current state pose a safety concern due to there being no suitable place to steady the user in case of a stumble.</p>	<p>Allow to carry out the following works:</p> <ul style="list-style-type: none"> Supply and install a welded steel handrail along one wall over the stairs. The handrail is to match those used within the remaining areas of the escape for specification

Item No	Item Description, Position & Cause	Scope of Works Required	Photograph If Necessary Or Applicable
	<p>Cause: The stairs were not constructed correctly in relation to the handrail provisions.</p>	<p>and finish.</p> <ul style="list-style-type: none"> The installation is to comply with the current BCA regulations. Make good any original surface finish affected by the remedial works Clean up on completion. <p>Performance Requirement</p> <ul style="list-style-type: none"> The effected stairs are to have a suitable handrail installed (matching the existing) ensuring compliance is achieved with the BCA provisions for handrail design and installation

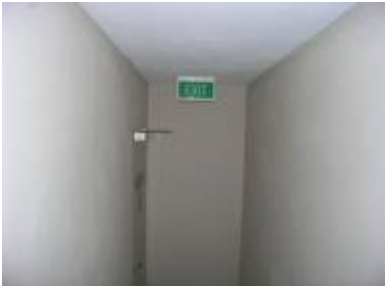
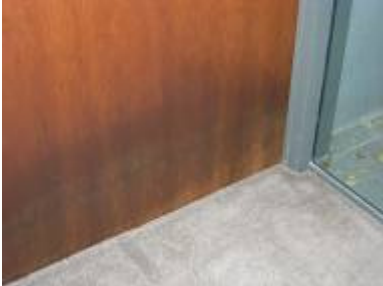
5	<p>Fire Escape, Eastern</p> <p>Description: There is no light to service the main north/south corridor leading to the garage discharge point.</p> <p>This area is left in comparative darkness and would leave this last section difficult to traverse in times of an emergency evacuation.</p> <p>Cause: A light was not installed to provide ample illumination.</p>	<p>Allow to carry out the following works:</p> <ul style="list-style-type: none"> Electrician to supply and install an additional overhead light to the corridor. The light fitting to be used is match the lights used in the other areas within the fire escape. The replacement light can be connected to the nearest light fitting using ceiling fixed grey electrical conduit. The positioning of the new light is not to impinge on the overall visibility of the Exit safety sign Make good any original surface finish affected by the remedial works Clean up on completion. <p>Performance Requirement</p> <ul style="list-style-type: none"> The darkened area of the stairs is to be illuminated sufficiently (without adversely

Item No	Item Description, Position & Cause	Scope of Works Required	Photograph If Necessary Or Applicable
		effecting the existing Exit sign) so as to ensure safe and unhindered passage in the time of an emergency evacuation	
	Entry Foyer, Western		
6	<p>Description: Previous water damage is evident to the base of the timber panelling on the western elevation wall adjacent to the glass entrance doors.</p> <p>The staining extends along the panels for approx 2000mm and extends up to approx 300mm high.</p> <p>I am instructed the builder had carried out works to the area which had rectified the cause of the water leak; however he was yet to make good the finished surfaces that were affected by the water entry.</p> <p>Dry moisture meter readings would confirm the leak has been fully addressed.</p> <p>Cause: All the works required to correct the original defect and all other consequential damages as a result of the original defect, exploratory and/or remedial works have not been fully completed. I am unable to provide any reason, other than speculation, as to why the builder failed to complete the rectification works.</p>	<p>Allow to carry out the following works:</p> <ul style="list-style-type: none"> Carefully remove and dispose of the water damaged timber faced wall sheeting Supply and install replacement matching wall sheeting Stain and or seal the replacement panel so as to match the original for specification and finish Make good all original surface finishes affected as part of the remedial works. Clean up on completion. <p>Performance Requirement</p> <ul style="list-style-type: none"> The existing damaged wall panels are to be removed and replaced so the finished panels have no evidence of water damage and match the existing

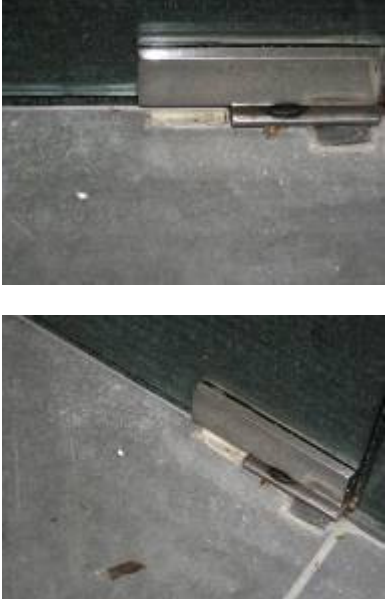
Entry Foyer, Eastern		
7	<p>Description: A section of floor tile measuring approx' 20mm x 50mm has been erroneously cut out next to the floor mounted swivel point for the western side glass door.</p> <p>This is leaving a highly visual defect</p>	<p>Allow to carry out the following works:</p> <ul style="list-style-type: none"> Mask around all adjoining tiles and provide dust protection for surrounding areas Carefully cut out and remove the effected tile and sufficient original tile bed to allow for new adhesive.

Item No	Item Description, Position & Cause	Scope of Works Required	Photograph If Necessary Or Applicable
	<p>Cause: The tile was incorrectly cut when initially installing</p>	<ul style="list-style-type: none"> • Allow to diamond saw cut the new (matching) replacement tile in order that it will fit around the parameters of the existing floor mounted swivel point with a uniform 5mm clearance at all cut edges • Fix the new replacement tile using a suitable cementitious based adhesive. • Allow to install colour matched flexible sealant similar in qualities to Sikaflex along all cut joints to where the grout will but up to a metal finish • Allow to grout fill all remaining open joint lines • Make good all original surface finishes affected as part of the remedial works • Clean up on completion. <p>Performance Requirement</p> <ul style="list-style-type: none"> • The existing poorly installed floor tile is to be removed and replaced with a correctly fitted tile that on completion does not have the appearance of a repair

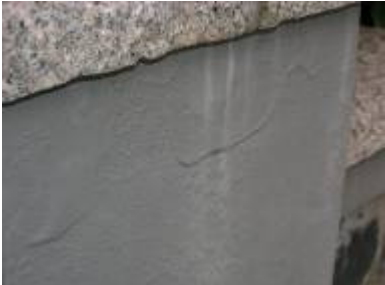
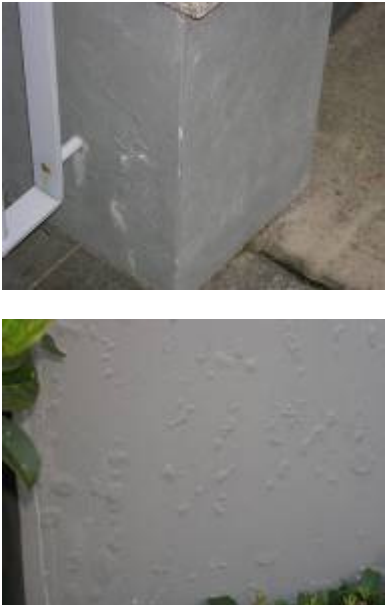
External Facade, Northern Elevation		
8	<p>Description: Blistering and delamination of the painted finish is evident to the following areas:</p> <ul style="list-style-type: none"> • The base of the front boundary fence columns. • Western face of the shaft wall positioned on the eastern side of the eastern entrance path. • Southern face of the eastern side wall to the eastern side undercover entrance foyer. <p>This is leaving a highly visual defect with the blistering being</p>	<p>Allow to carry out the following works:</p> <ul style="list-style-type: none"> • Scrape back and remove all loose and delaminated areas of painted finish to the front elevation area. • In consultation with the paint manufacturer, carry out all necessary preparation to the walls prior to re-painting with an appropriate product from shadow line to shadow line to match the original for texture and colour.

Item No	Item Description, Position & Cause	Scope of Works Required	Photograph If Necessary Or Applicable
	<p>especially advanced along the base of the boundary fence and at the rear of the shaft wall.</p> <p>Cause: Without the paints being checked and tested by the manufacturer and/or other accredited paint specialist, an exact cause is unable to be determined at this point of time; however it is considered the paint is blistering due to moisture getting into the render behind.</p> <p>The effects of heat and mineral salt growth have caused the paint to delaminate from the base material.</p>	<ul style="list-style-type: none"> Clean up on completion. <p>Performance Requirement</p> <ul style="list-style-type: none"> The currently failed areas of paint are to be stripped back, treated and re-painted so as to prevent a future occurrence of the blistering

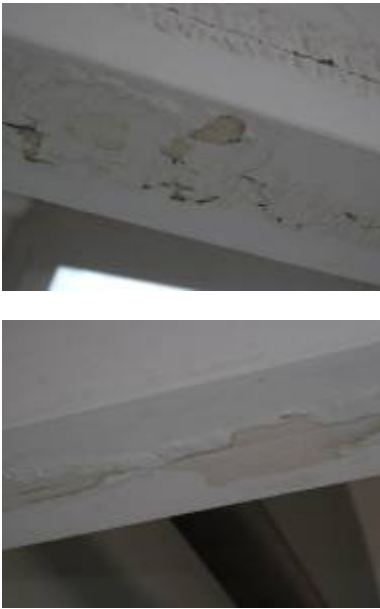
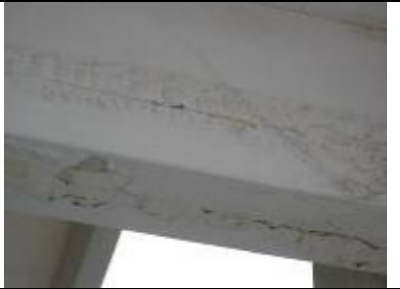
10	<p>External Façade, Northern Elevation</p> <p>Description: The three upper level external balconies have each suffered from water leaks from the box gutter arrangement causing damage to the set joints and painted finish of the sheeted ceiling soffits.</p> <p>I am instructed that in times of heavy rain, water is still seen to be leaking into and through the soffits.</p> <p>At the time of the inspection the soffits registered a dry reading when tested with a moisture meter, however in view of the instructions received by an owner it is considered the dry reading is due to the leaks only occurring in certain climatic conditions and therefore the area has been able to dry fully since the last leak.</p> <p>An on roof inspection was unable to determine any obvious point of water entry, however due to height and access limitations, tiles were not removed.</p> <p>Cause: Without carrying out destructive exploratory works, an exact cause is unable to be determined at this point of time; however it is considered the cause is a defect with the valley flashing to box gutter interface.</p>	<p>Allow to carry out the following works:</p> <ul style="list-style-type: none"> Access roof area, remove roof tiles, and carry out all water tests necessary to identify the point of water entry. Correct current source of water entry and prevent any future recurrence. Make good all original surface finishes affected as part of the original leak, exploratory and remedial works. Clean up on completion. P.A of \$6000.00 <p>Performance Requirement</p> <ul style="list-style-type: none"> The current leak source is to be identified and corrected so as to prevent any further occurrences. All affected surface finishes are to be restored to match original specifications and finish

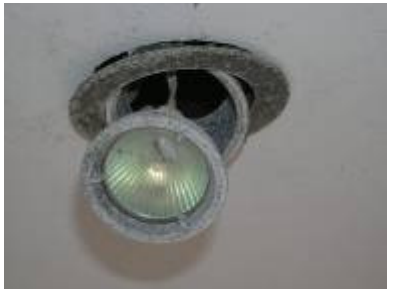
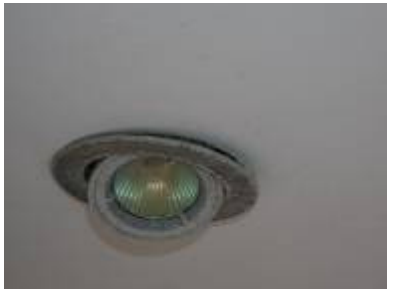
11	<p>External Façade, Northern Elevation</p> <p>Description: The down lights fitted to the soffits of the upper level balconies are all suffering from severe surface corrosion.</p> <p>It should be noted that the positioning of the development is within 500m of the harbour with direct views out to the heads so it is well within a marine environment.</p> <p>Cause: It is considered the light fittings installed were not suitable for the marine environment which has brought on the advanced surface corrosion.</p>	<p>Allow to carry out the following works:</p> <ul style="list-style-type: none"> Electrician to remove, dispose and replace the corroded light fittings with new units of the correct grade of 316 stainless steel. Allow to replace the existing transformers and low voltage connection wiring Clean up on completion. <p>Performance Requirement</p> <ul style="list-style-type: none"> The replacement lights are to of the same style and size, however they are to be of a grade of stainless steel which is suitable for the aggressive marine environment and not suffer from premature corrosion

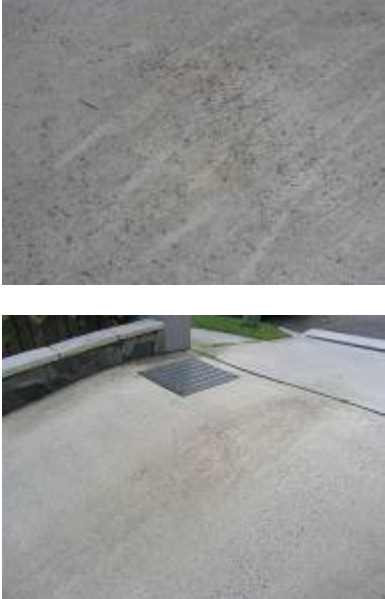
12	<p>External Façade, Northern Elevation</p> <p>Description: I am instructed that when exiting and entering the drive a number of cars (unless extra special care and procedures are used) will</p>	<p>Allow to carry out the following works:</p> <ul style="list-style-type: none"> Cut out, break up, remove and dispose of the final concrete panel prior to the boundary control joint line Drill and install 10mm starter bars at 400

Item No	Item Description, Position & Cause	Scope of Works Required	Photograph If Necessary Or Applicable
	<p>scrape on the drive at the top adjacent to the footpath crossing.</p> <p>It is noted the drive has a reasonably sharp change of angle just inside the grated drain cover at the top of the drive.</p> <p>Cause: The drive has been set up with a profile at the top which is not suitable to allow for normal vehicle usage.</p>	<p>centres along the mid depth line of the exposed concrete panel edges</p> <ul style="list-style-type: none"> • Re-form and mark the existing perimeter walls for a slightly more rounded profile in from the boundary line • Modify the top of the grated sump to match the new drive profile • Lay new 10mm sheet steel 200mm bar spacing's set on bar chairs • Lay new 25mpa concrete set to the new profile and wood float finished to match the existing • Make good all original surface finishes affected as part of the original leak, exploratory and remedial works. • Clean up on completion. <p>Performance Requirement</p> <ul style="list-style-type: none"> • The drive is to be modified so as to allow the 'average' car to transverse without scraping its underside

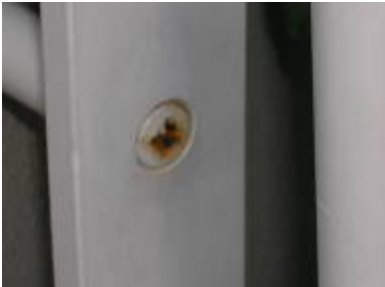
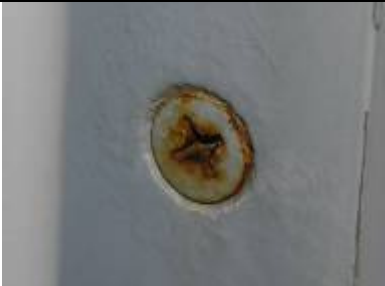
13	<p>External Façade, Northern Elevation</p> <p>Description: The screw side fixings for the front boundary powder coated fence are all suffering from corrosion.</p> <p>It should be noted that the positioning of the development is within 500m of the harbour with direct views out to the heads so it is well within a marine environment.</p> <p>Cause: It is considered the screws installed had minimal surface protection</p>	<p>Allow to carry out the following works:</p> <ul style="list-style-type: none"> • Remove and replace the screw fixings with new marine grade 306 stainless steel units suitable • Clean up on completion. <p>Performance Requirement</p> <ul style="list-style-type: none"> • The replacement fixings are to be of the same size and style of the existing, however they do not require to be colour matched.

Item No	Item Description, Position & Cause	Scope of Works Required	Photograph If Necessary Or Applicable
	which was damaged by the act of tightening with a screwdriver leaving them susceptible for early onset of corrosion due to the marine environment.	<ul style="list-style-type: none"> They are to be of a suitable grade stainless steel so as not to suffer from premature corrosion

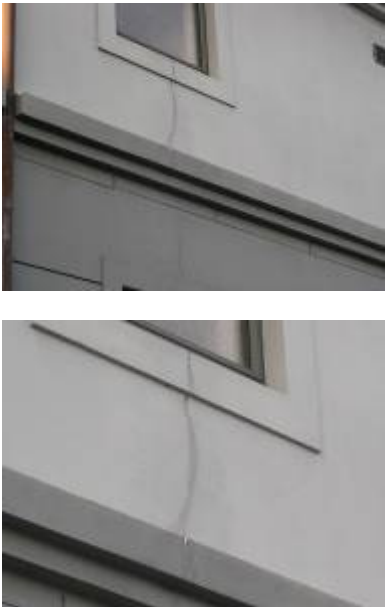
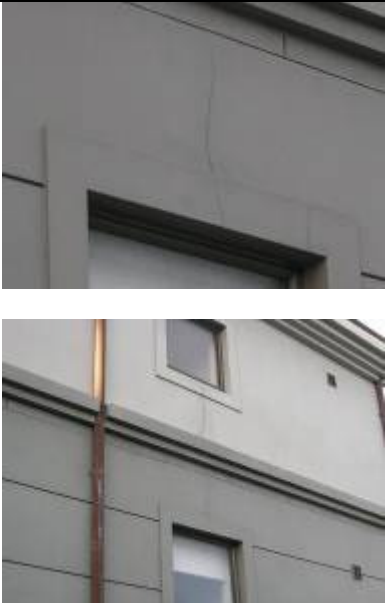
External Facade, Western Elevation		
14	<p>Description: Vertical cracking had previously been evident to the wall render running up through the line of the two ensuite windows positioned just to the southern side of the garage door opening.</p> <p>I am instructed the builder had returned to site and carried out some works to the cracks which involved cutting out, re-rendering and painting.</p> <p>The result of these works is the render used is not of a suitable quality to match the existing for texture and smoothness and the painted finish is only a patch paint effort of which makes the area of repair highly visible.</p> <p>Cause: The works were not carried out and completed so as to match the original for specification and finish when completed.</p> <p>I am unable to provide any reason other than speculation as to why the builder failed to complete the rectification works to match the existing.</p>	<p>Allow to carry out the following works:</p> <ul style="list-style-type: none"> Allow to diamond saw cut the render for a distance of approx 200mm either side of the existing crack line Remove the render back to the base masonry Supply and fix stainless steel expanded mesh over the exposed masonry area Allow to re-render the area using a 6:1:1 mix ensuring the new render is finished off flush with all adjoining surfaces and matches the original for texture and profile. Seal and patch paint the areas of repair prior to re-painting the affected wall areas from shadow line to shadow line. Make good all original surface finishes affected as part of the remedial works Clean up on completion. <p>Performance Requirement</p> <ul style="list-style-type: none"> The area of cracked render is to be removed and replaced and on completion the wall is not to appear to have been patch repaired in that

Item No	Item Description, Position & Cause	Scope of Works Required	Photograph If Necessary Or Applicable
		the finish is to be uniform

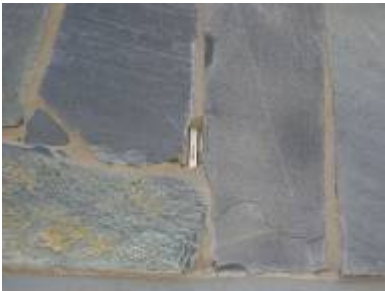
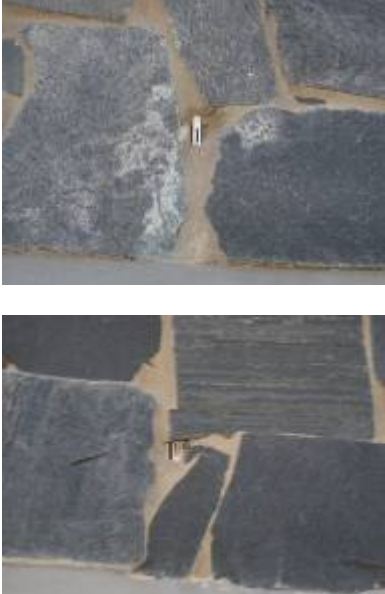
15	<p>External Façade, Western Elevation</p> <p>Description: Failure of the grouting between the decorative stone wall facing sections, above the area of the garage door opening is evident.</p> <p>The grouting has failed in three positions exposing plastic fittings behind.</p> <p>This has left a highly visual defect clearly evident as you drive into the garage.</p> <p>Cause: The plastic fittings have been allowed to intrude into the grout to the point where the overall thickness of the sand/cement grout has</p>	<p>Allow to carry out the following works:</p> <ul style="list-style-type: none"> • Cut back the plastic fittings to ensure a minimum grout depth of 10mm can be achieved. • Treat the areas with a bonding agent prior to applying a new colour matched grout to the failed areas. • Acid clean down the decorative stone finish to remove any excessive mortar smearing from the works • Make good any original finish effected as part of the remedial work • Clean up on completion.

Item No	Item Description, Position & Cause	Scope of Works Required	Photograph If Necessary Or Applicable
	<p>been lessened to approx 3mm in depth.</p> <p>This minimal depth is unable to accommodate the normal thermal expansion and contraction experienced and, as a result, the grout over the fittings has cracked and failed.</p>	<p>Performance Requirement</p> <ul style="list-style-type: none"> The area of failed render is to be removed and replaced and on completion the wall is not to appear to have been patch repaired in that the finish to grout joint lines are to be uniform

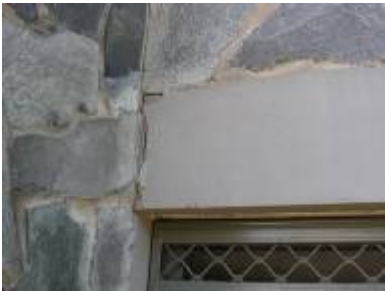
16	<p>External Façade, Western Elevation</p> <p>Description: Vertical cracking and delamination to the wall render is evident to the northern end of the beam over the garage door opening at the interface with the stone faced drive wall.</p> <p>The delamination is affecting the last 20mm of the beam for its full height.</p> <p>Small sections of render have already delaminated and fallen.</p> <p>Cause: The cracking is a result of this section of wall being unable to accommodate the movement experienced between it and the side</p>	<p>Allow to carry out the following works:</p> <ul style="list-style-type: none"> Carefully cut back the render to the beam using a straight vertical line forming an open joint line between the rendered beam and stone faced wall of approx 20mm wide. Tape either side of the open joint line and fill with a colour matched external grade flexible sealant formed to be a control joint line. Seal and patch paint the areas of repair prior to re-painting the affected areas from shadow line to shadow line. Clean up on completion. <p>Performance Requirement</p>

Item No	Item Description, Position & Cause	Scope of Works Required	Photograph If Necessary Or Applicable
	<p>drive wall at the interface.</p> <p>Without adequate precautions such as functioning slip and control joints, uncontrolled cracking will be the result.</p>	<ul style="list-style-type: none"> The area of failed render is to be removed and replaced and on completion the wall is not to appear to have been patch repaired

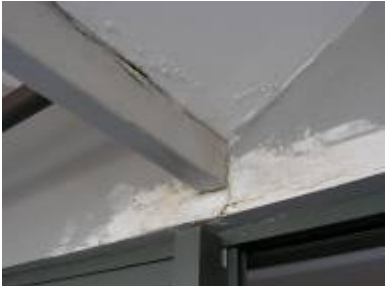
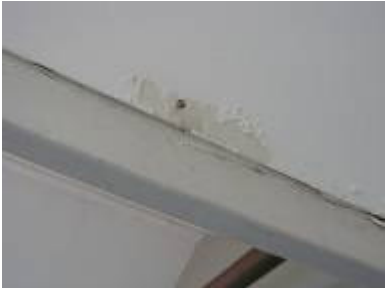
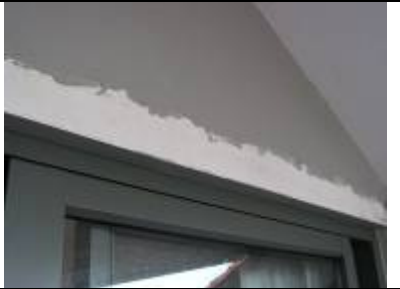
External Facade, Southern Elevation		
17	<p>Description: The three upper level external balconies have each suffered from water leaks from the box gutter arrangement causing damage to the set joints and painted finish of the sheeted ceiling soffits.</p> <p>I am instructed that in times of heavy rain, water is still seen to be leaking into and through the soffits.</p> <p>At the time of the inspection the soffits registered a dry reading when tested with a moisture meter, however in view of the instructions received by an owner it is considered the dry reading is due to the leaks only occurring in certain climatic conditions and therefore the area has been able to dry fully since the last leak.</p> <p>An on roof inspection was unable to determine any obvious point of water entry, however due to height and access limitations, tiles were not removed.</p> <p>Cause: Without carrying out destructive exploratory works, an exact cause is unable to be determined at this point of time; however it is considered the cause is a defect with the valley flashing to box gutter interface.</p>	<p>Allow to carry out the following works:</p> <ul style="list-style-type: none"> Access roof area, remove roof tiles, and carry out all water tests necessary to identify the point of water entry. Correct current source of water entry and prevent any future recurrence. Make good all original surface finishes affected as part of the original leak, exploratory and remedial works. Clean up on completion. P.A of \$6000.00 <p>Performance Requirement</p> <ul style="list-style-type: none"> The current leak source is to be identified and corrected so as to prevent any further occurrences. All affected surface finishes are to be restored to match original specifications and finish

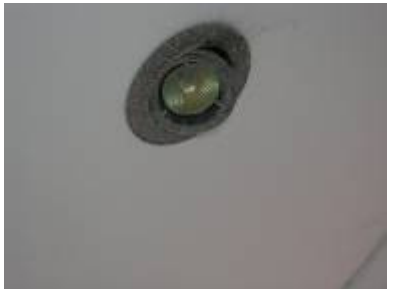
18	<p>External Façade, Southern Elevation</p> <p>Description: The down lights fitted to the soffits of the upper level balconies are all suffering from severe surface corrosion.</p> <p>It should be noted that the positioning of the development is within 500m of the harbour with direct views out to the heads so it is well within a marine environment.</p> <p>Cause: It is considered the light fittings installed were not suitable for the marine environment which has brought on the advanced surface corrosion.</p>	<p>Allow to carry out the following works:</p> <ul style="list-style-type: none"> Electrician to remove, dispose and replace the corroded light fittings with new units of the correct grade of 316 stainless steel. Allow to replace the existing transformers and low voltage connection wiring Clean up on completion. <p>Performance Requirement</p> <ul style="list-style-type: none"> The replacement lights are to of the same style and size, however they are to be of a grade of stainless steel which is suitable for the aggressive marine environment and not suffer from premature corrosion

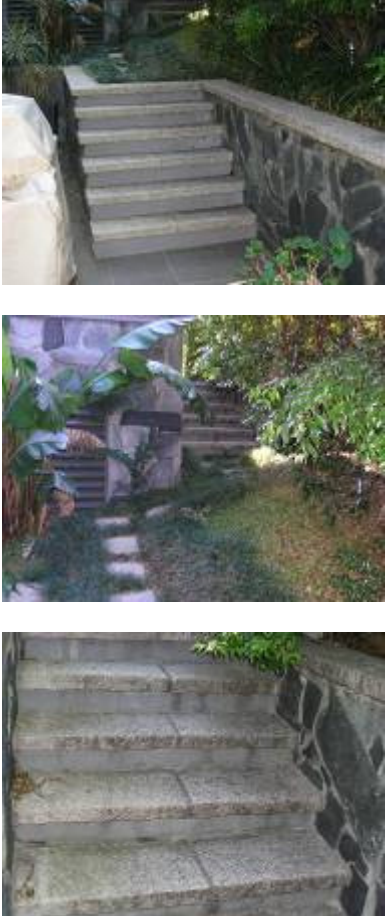
External Facade, Eastern Elevation		
19	<p>Description: There is no handrail servicing the three stair flights leading down through the garden area to the eastern side of Unit 3.</p> <p>The stairs in their current state pose a safety concern due to there being no suitable place to steady the user in case of a stumble.</p>	<p>Allow to carry out the following works:</p> <ul style="list-style-type: none"> Supply and install a handrail to one side over each set of stairs. The handrail is to match those used in other external areas of the development or be sympathetic to the design and quality of the

Item No	Item Description, Position & Cause	Scope of Works Required	Photograph If Necessary Or Applicable
	<p>Cause: The stairs were not constructed correctly in relation to the handrail provisions.</p>	<p>materials used as well as being suitable for a marine environment.</p> <ul style="list-style-type: none"> • The installation is to comply with the current BCA regulations. • Make good any original finish affected as apart of the remedial works • Clean up on completion <p>Performance Requirement</p> <ul style="list-style-type: none"> • The effected stairs are to have a suitable handrail installed (matching the existing) ensuring compliance is achieved with the BCA provisions for handrail design and installation

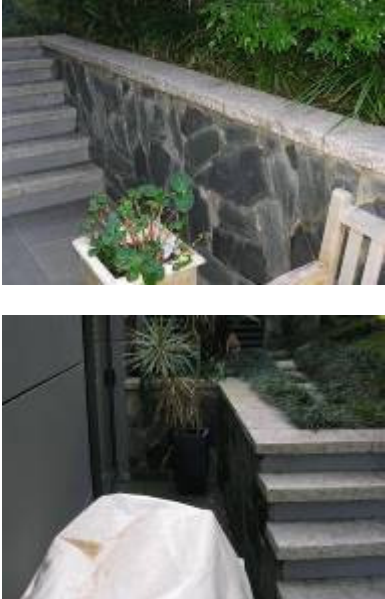
20	<p>External Façade, Eastern Elevation</p> <p>Description: An unprotected and accessible fall of in excess of 1m in height is evident to two garden areas positioned to the eastern side of Unit 3.</p>	<p>Allow to carry out the following works:</p> <ul style="list-style-type: none"> • Supply and install a suitable balustrade to prevent persons from accessing the area to where the unprotected fall is in excess of 1m. • The balustrade is to match those used in other

Item No	Item Description, Position & Cause	Scope of Works Required	Photograph If Necessary Or Applicable
	<p>These sections of garden are directly accessible from the garden stairs and in one instance from the side of a path.</p> <p>Cause: No balustrade has been installed to either prevent access, or protect the fall from the nominated area.</p>	<p>external areas of the development, or be sympathetic to the design and quality of the materials used, as well as being suitable for a marine environment.</p> <ul style="list-style-type: none"> Clean up on completion. <p>Performance Requirement</p> <ul style="list-style-type: none"> The effected wall is to have a suitable balustrade installed (matching the existing) ensuring compliance is achieved with the BCA provisions for balustrade design and installation

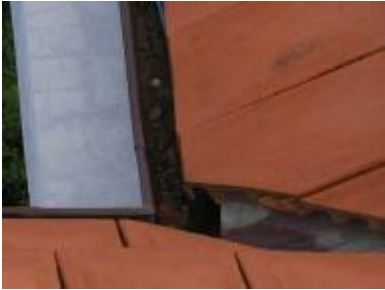
Roof		
21	<p>Description: I am instructed that during periods of heavy rainfall, water will overflow the eaves gutter in the area just south of the re-entrant corner on the western elevation.</p> <p>Cause: An on roof inspection showed this section of guttering has had the flow rates and capacity greatly diminished by a section of roof sarking which has been allowed to extend into the gutter and partially block. There is also a large build up of debris (sand etc) within the gutter further reducing flow.</p>	<p>Allow to carry out the following works:</p> <ul style="list-style-type: none"> Clean out the area of guttering of all builders' debris to ensure the flow is unimpeded. Ensure the falls of the guttering in the area are set correctly. Make good any original surface finish effected as part of the remedial works Clean up on completion. <p>Performance Requirement</p> <ul style="list-style-type: none"> The guttering to the nominated area is to be cleaned and re-graded so as to prevent

Item No	Item Description, Position & Cause	Scope of Works Required	Photograph If Necessary Or Applicable
		overflow during periods of heavy rain

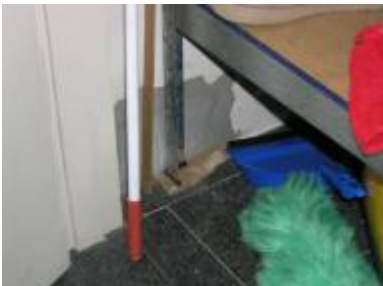
INDIVIDUALLY OWNED PROPERTIES. Including Common/Lot Property Assessment		
	Unit 1		
22	<p>Description: Moisture transfer through to the southern elevation wall of the linen closet was previously evident.</p> <p>I am instructed the builder had returned to site and carried out some works within the linen closet which included the removal and replacement of a section of wall render, approx 300mm x 200mm, at the base of the southern elevation wall.</p> <p>The area when tested with a moisture meter showed readings of less than 13% which are considered to be dry.</p> <p>In view of the above, it is therefore considered (agreed to by the unit owner) the leak through to the linen closet has been rectified.</p> <p>Even through the builder appears to have rectified the leak, he is yet to make good the damages caused to original surface finishes as a result of the remedial works.</p> <p>Cause: All the works required to correct the original defect and all other consequential damages as a result of the original defect, exploratory and/or remedial works have not been fully completed.</p>	<p>Allow to carry out the following works:</p> <ul style="list-style-type: none"> Seal and patch paint the area of repair prior to re-painting the entire wall area from shadow line to shadow line. The paint used is to match the original for specification and finish Clean up on completion. <p>Performance Requirement</p> <ul style="list-style-type: none"> The wall area once painted is not to look like it has been patched

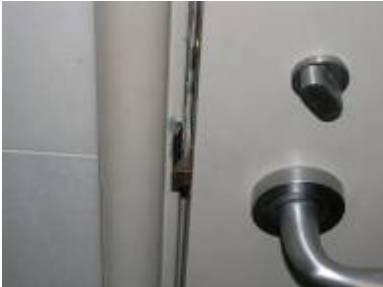
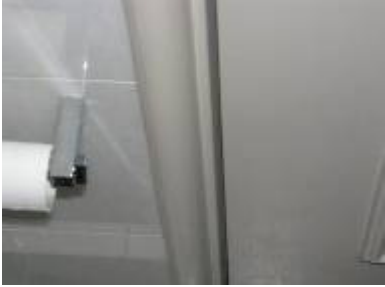
24	<p>Unit 1</p> <p>Description: The lock side door gap for the powder room measures up to 8mm in width and is creating a highly visual defect.</p> <p>This is well in excess of the 3mm outlined within the NSW Office of Fair Trading Guide to Standards and Tolerances as an acceptable door gap.</p> <p>Cause:</p>	<p>Allow to carry out the following works:</p> <ul style="list-style-type: none"> • Remove the door lock striker plate from the door jamb • Supply and install a 'plant' section of timber down the face of the lock style of the jamb in order to reduce the current excessive gap between the door edge and jamb. • Carry out all filling and patching of the plant section to ensure it is moulded smoothly into the existing jamb without any evidence of it being

Item No	Item Description, Position & Cause	Scope of Works Required	Photograph If Necessary Or Applicable
	<p>The relationship between the WC and door leaf is extremely tight and as a result, in order to get the door to open past the line of the WC, the door had to be planed back to the present gap.</p> <p>This gapping has solved the opening issue; however it has created a separate visual defect. Home Building Act, Section 18B, Paragraphs A & B.</p>	<p>an addition</p> <ul style="list-style-type: none"> • Allow to make allowances within the planted section to have the striker plate re-fixed. • Seal and prime the plant prior to re-painting the jamb to match the original for specification and finish • Re-fix the striker plate • Make good all original surface finishes affected as part of the remedial works. • Clean up on completion. <p>Performance Requirement</p> <ul style="list-style-type: none"> • The door jamb is to be modified so as to achieve a maximum 3mm door gap

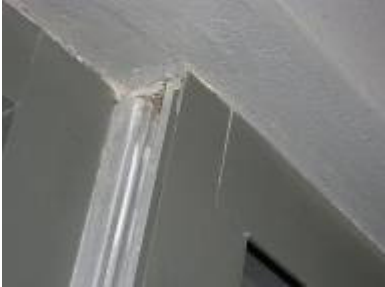
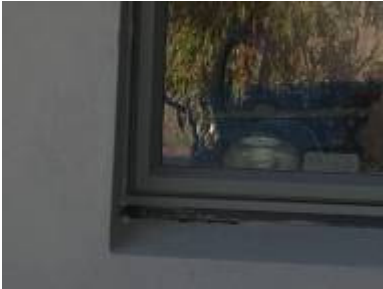
25	<p>Unit 1</p> <p>Description: The sliding door and window frames have been provided with a coloured powder-coated finish; however the western end of the sliding door frame to the upper level balcony has been left with a raw ribbed aluminium finish clearly visible.</p> <p>Section 3.1 on page 74 of the building specifications clearly states the windows are all to be powder coated to a material thickness of 50 Microns.</p> <p>This has not been achieved to all of the visible faces</p> <p>Cause: From the way the door and adjoining window frames have been set up (not in a line with each other but stepped approx 50mm) there should have been an end cover section from the window manufacturer supplied and installed to cover the raw edge.</p>	<p>Allow to carry out the following works:</p> <ul style="list-style-type: none"> • Arrange for the window manufacturer to supply and install a snap on section of matching powder coated materials to cover the exposed aluminium to the western end of the sliding door. • Clean up on completion. <p>Performance Requirement</p> <ul style="list-style-type: none"> • A colour and finished matched section of aluminium trim is to be supplied and installed to create a factory finish to the western end

Item No	Item Description, Position & Cause	Scope of Works Required	Photograph If Necessary Or Applicable
	I am unable to provide any reason, other than speculation, as to why the builder failed to supply and install the required finish section.		
26	<p>Unit 1</p> <p>Description: The rubber seal fitted to the sill section of the southern facing kitchen window is not of a sufficient width to reach the top of the angled masonry sill.</p> <p>The sill has not been constructed with sufficient width and angle to reach the underside of the window frame and therefore allow the rubber weather seal to cover the transition area.</p> <p>As a result of the incorrect detailing, the cavity area below the window is now open to wind driven rain and vermin entry.</p> <p>Cause: The final rendering of the sill was not carried out in order to terminate sufficiently up and under the window sill section to enable the sealing strip to rest down over the top of the brick sill.</p>	<p>Allow to carry out the following works:</p> <ul style="list-style-type: none"> • Scabble back the surface of the sill render back to either base masonry or clean render. • Apply a bonding agent similar. • Re-render the sill ensuring its new profile will allow for the rubber sealing strip to fully cover the junction between sill and window frame. • Seal and patch paint the new works • Allow to re-paint the new sill and effected wall sections from shadow line to shadow line in a paint to match the original for specification and finish • Make good all original surface finishes affected as part of the remedial works. • Clean up on completion. <p>Performance Requirement</p> <ul style="list-style-type: none"> • The window sill is to be re-profiled so as the factory fit rubber sealing strip will reach down onto the new profile

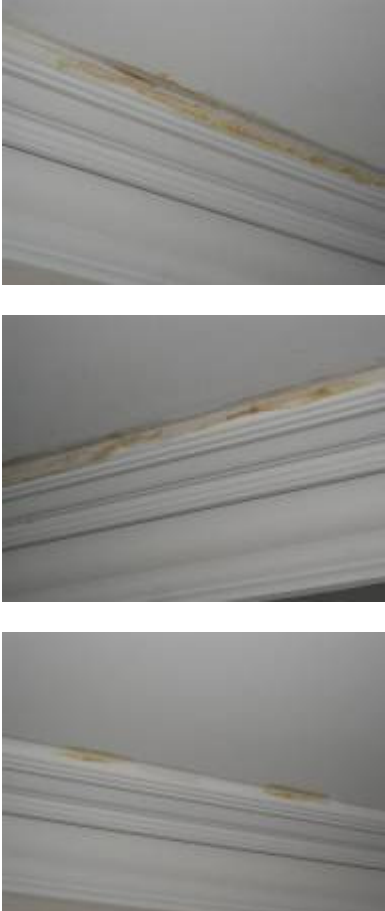
27	<p>Unit 1</p> <p>Description: I am instructed by the unit owner that cornice sections to the following perimeter walls had failed at the ceiling to cornice junction lines resulting in cracks in excess of 1mm in width forming.</p> <ul style="list-style-type: none"> • Western elevation wall of bedroom 1. 	<p>Allow to carry out the following works:</p> <ul style="list-style-type: none"> • Mechanically fix the cornice sections to the ceiling. • Carefully scrape back and remove the excess glue from previous rectification attempts • Carry out any and all necessary plaster repairs

Item No	Item Description, Position & Cause	Scope of Works Required	Photograph If Necessary Or Applicable
	<ul style="list-style-type: none"> Eastern elevation wall of front northern patio area. Southern elevation wall of lounge. <p>The owner has previously carried out his own repairs in order to stop the cracking from continuing.</p> <p>He has adhered the cornice sections back into position, however in the act of doing this work; some adhesive smearing is now evident to the cornice and ceiling to the affected areas.</p> <p>Cause: The cracking is a result of this section of cornice being unable to accommodate the movement experienced within the main structure of the building due to the different rates of movement between the concrete (will shrink) and masonry (will expand) members.</p> <p>Without adequate precautions such as functioning slip and control joints, uncontrolled cracking will be the result.</p>	<p>to the cornice and ceiling from the mechanical fixing and glue removal procedures. Leave ready for painting</p> <ul style="list-style-type: none"> Seal and patch paint the areas of repair to the cornice and ceiling. Allow to re-paint the affected areas of ceiling and cornice from shadow line to shadow line using a paint to match the original for specification and finish. Clean up on completion. <p>Performance Requirement</p> <ul style="list-style-type: none"> The cornice is to be soundly fixed into position and damage caused by the previous repair attempts fully rectified. The ceiling and cornice is are to be repainted and show no indication of repairs

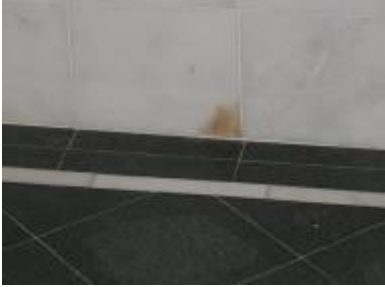
28	<p>Unit 1</p> <p>Description: Corrosion type staining is evident within the marble wall tile to the wall area underneath bedroom 1 ensuite vanity cabinet.</p>	<p>Allow to carry out the following works:</p> <ul style="list-style-type: none"> Remove the affected wall tiles and closest floor tiles ensuring the existing waterproofing arrangements are left undamaged and/or are repaired.

Item No	Item Description, Position & Cause	Scope of Works Required	Photograph If Necessary Or Applicable
	<p>The area of staining is at the base of the tile and is approx 50mm in diameter.</p> <p>At this point of time only two tiles are affected.</p> <p>Cause: Without destructive exploratory works, a precise cause is unable to be determined, however it is considered to have been caused by a nail or small piece of ferrous steel contaminate being within the floor tile bedding and the staining is leaching up the rear of the wall tile via capillary action.</p>	<ul style="list-style-type: none"> Identify and remove the corrosion affected tile bedding including the cause. Supply and lay new floor and wall tiles finished off to match the existing. Make good all original surface finishes affected as part of the remedial works. Clean up on completion. <p>Performance Requirement</p> <ul style="list-style-type: none"> The corrosion stained tile is to be removed and replaced whilst leaving a finish to where repairs are not evident

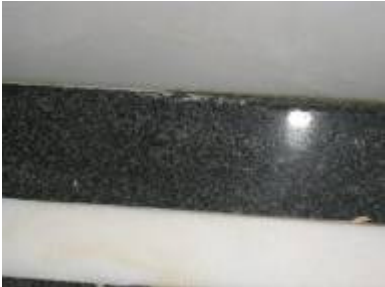
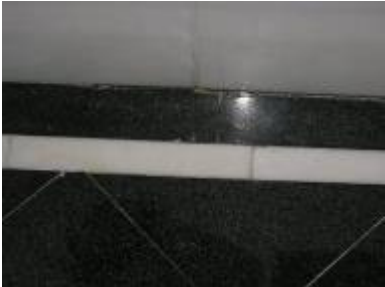
29	<p>Unit 1</p> <p>Description: Moisture transfer through to the southern elevation wall of the linen closet was previously evident.</p> <p>I am instructed the builder had returned to site and carried out works within the linen closet which appear to have addressed the defect, see item 22 above.</p> <p>I am instructed by the unit occupant that since these repairs have occurred he is now noticing water/moisture transfer through bedroom 1 ensuite eastern elevation wall which backs on to the powder room.</p> <p>This now constant moisture is resulting in efflorescence growth at the wall to floor junction of the ensuite eastern elevation wall and the corrosion staining noted in item 28 above.</p> <p>Cause: It was previously considered that a water leak may be evident at the</p>	<p>Allow to carry out the following works:</p> <ul style="list-style-type: none"> Plumber to disconnect the cistern from the WC Carefully remove the WC and store for re-use Plumber to check on all concealed drainage line fittings and replace sealing rings etc where applicable Re-fix the WC and re-connect the cistern. Clean up on completion. <p>Performance Requirement</p> <ul style="list-style-type: none"> The WC is to be removed and re-fixed ensuring that all plumbing connections are checked and made 100% waterproof so as to prevent any further leakage

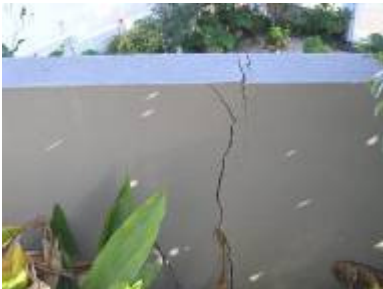
31	<p>Unit 1</p> <p>Description: Vertical cracking to the southern elevation yard retaining wall was evident to the following areas:</p> <ul style="list-style-type: none"> Cracking of up to 5mm in width to the angled section of wall to the south western corner. Cracking of up to 1.5mm in width to the southern section of wall at approx mid span. <p>The render either side of the crack was checked and found to be emitting a drummy noise indicating loss of adhesion with the base wall.</p> <p>Cause:</p>	<p>Allow to carry out the following works:</p> <ul style="list-style-type: none"> Allow to diamond saw cut the render for a distance of approx 1000mm either side of the existing crack line Remove the render back to the base masonry Supply and fix stainless steel Heli-fix bars across the crack line in accordance with the manufacturers recommendations Supply and fix stainless steel expanded mesh over the exposed masonry area Allow to re-render the area using a 6:1:1 mix ensuring the new render is finished off flush with all adjoining surfaces and matches the original for texture and profile.

Item No	Item Description, Position & Cause	Scope of Works Required	Photograph If Necessary Or Applicable
	<p>The cracking is a result of this section of wall being unable to accommodate the movement experienced.</p> <p>Without adequate precautions such as functioning slip and control joints, uncontrolled cracking will be the result.</p>	<ul style="list-style-type: none"> Seal and patch paint the areas of repair prior to re-painting the affected wall areas from shadow line to shadow line. Make good all original surface finishes affected as part of the remedial works Clean up on completion. <p>Performance Requirement</p> <ul style="list-style-type: none"> The area of cracked render is to be removed and replaced, the wall stitched and on completion the wall is not to appear to have been patch repaired in that the finish is to be uniform

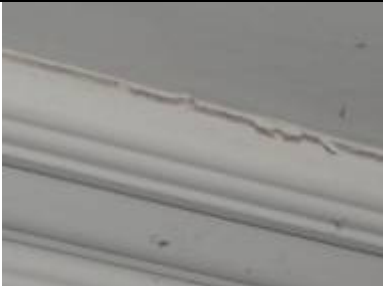
Item No	Item Description, Position & Cause	Scope of Works Required	Photograph If Necessary Or Applicable
32	<p>Unit 2</p> <p>Description: The western elevation (perimeter wall) cornice to the bed 1 covered patio area has become detached from the soffit area resulting in a crack of up to 2.5mm in width forming along this junction line</p> <p>Cause: The cracking is a result of this section of cornice being unable to accommodate the movement experienced within the main structure of the building due to the different rates of movement between the concrete (will shrink) and masonry (will expand) members.</p> <p>Without adequate precautions such as functioning slip and control joints, uncontrolled cracking will be the result.</p>	<p>Allow to carry out the following works:</p> <ul style="list-style-type: none"> Mechanically fix the cornice sections to the ceiling. Carry out any and all necessary plaster repairs to the cornice and ceiling from the mechanical fixing procedure. Leave ready for painting Seal and patch paint the areas of repair to the cornice and ceiling. Allow to re-paint the affected areas of ceiling and cornice from shadow line to shadow line using a paint to match the original for specification and finish. Clean up on completion. <p>Performance Requirement</p> <ul style="list-style-type: none"> The cornice is to be soundly fixed into position and damage caused by the previous repair attempts fully rectified. The ceiling and cornice is are to be repainted and show no indication of repairs

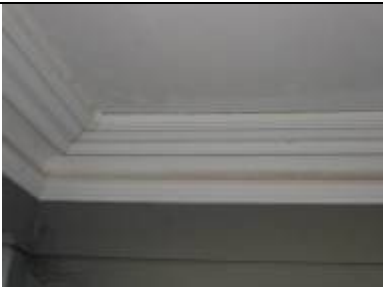
33	<p>Unit 2</p> <p>Description: The western elevation (perimeter wall) cornice to the lounge covered patio area has become detached from the soffit area resulting in a crack of up to 2.5mm in width forming along this junction line</p> <p>Cause: The cracking is a result of this section of cornice being unable to accommodate the movement experienced within the main structure of the building due to the different rates of movement between the</p>	<p>Allow to carry out the following works:</p> <ul style="list-style-type: none"> Mechanically fix the cornice sections to the ceiling. Carry out any and all necessary plaster repairs to the cornice and ceiling from the mechanical fixing procedure. Leave ready for painting Seal and patch paint the areas of repair to the cornice and ceiling. Allow to re-paint the affected areas of ceiling and cornice from shadow line to shadow line using a paint to match the original for

Item No	Item Description, Position & Cause	Scope of Works Required	Photograph If Necessary Or Applicable
	<p>concrete (will shrink) and masonry (will expand) members.</p> <p>Without adequate precautions such as functioning slip and control joints, uncontrolled cracking will be the result.</p>	<p>specification and finish.</p> <ul style="list-style-type: none"> Clean up on completion. <p>Performance Requirement</p> <ul style="list-style-type: none"> The cornice is to be soundly fixed into position and damage caused by the previous repair attempts fully rectified. The ceiling and cornice is are to be repainted and show no indication of repairs

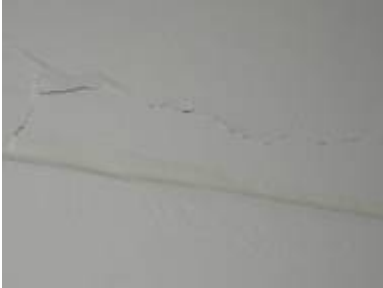
Item No	Item Description, Position & Cause		Scope of Works Required	Photograph If Necessary Or Applicable
	Unit 3			
35	<p>Description: A horizontal crack with delamination of the wall render is evident to the northern elevation wall of the north eastern corner bedroom.</p> <p>It would appear that the wall has been re-painted over, however the crack and the delaminated render, confirmed by tapping with a metallic object, and is still evident.</p> <p>The positioning of the crack is approx 40mm above the line of a struck joint within the render.</p> <p>Cause: As the struck joint line within the render is only approx 3mm in depth it is therefore forming little or no purpose in controlling cracking.</p> <p>In order to be effective, the joint line has to be positioned correctly (at the junction between dissimilar base materials and be set for the full depth of the render).</p>		<p>Allow to carry out the following works:</p> <ul style="list-style-type: none"> Carefully cut and remove the area of delaminated render for a distance of approx 250mm either side of the crack lines. Treat the base masonry wall with a bonding agent similar to 'Bondcrete'. If considered necessary, cut and place stainless steel expanded mesh over the crack line to provide some form of reinforcement and resistance to future cracking. Re-render the area of repair ensuring the render is finished off flush with the adjoining surfaces and with a texture to match the existing. Ensure that the required struck joint line is correctly positioned and detailed within the new render. Seal and patch paint the areas of repair prior to re-painting the affected areas from shadow line to shadow line. Clean up on completion. <p>Performance Requirement</p> <ul style="list-style-type: none"> The area of cracked render is to be removed and replaced and on completion the wall is not to appear to have been patch repaired in that the finish is to be uniform

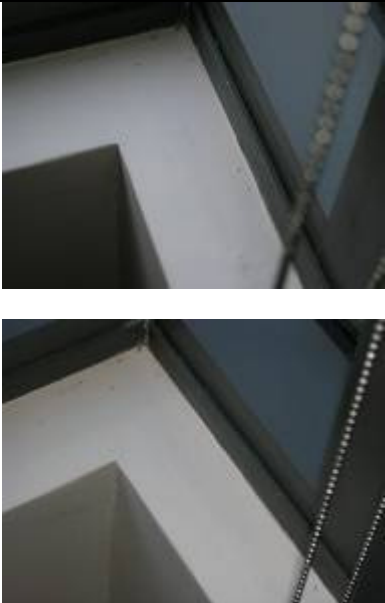
36	Unit 3		<p>Allow to carry out the following works:</p> <ul style="list-style-type: none"> Carefully remove and store the window for re- 	
	Description:

Item No	Item Description, Position & Cause	Scope of Works Required	Photograph If Necessary Or Applicable
	<p>External water entry in the form of staining and damage to the wall and sill linings is evident beside and below the fixed glass window to the south east corner of the lounge.</p> <p>When tested with a moisture meter, readings in excess of 20% were taken.</p> <p>It was noted that some minor paint repairs and touch ups had been carried out; however the issue regarding the water entry is still to be addressed.</p> <p>Cause: Without carrying out destructive exploratory works, an exact cause is unable to be determined at this point of time, however it is considered the cause is either missing or incorrectly installed sill flashing.</p>	<p>use.</p> <ul style="list-style-type: none"> • Supply and install new sill flashing ensuring correct detailing into the cavity flashing to prevent any water from entering the dwelling. • Re-fix the window frame. • Seal and patch paint any areas of repairs prior to re-painting from shadow line to shadow line so as to match the existing for specification and finish • Make good all original surface finishes affected as part of the remedial works. • Clean up on completion. <p>Performance Requirement</p> <ul style="list-style-type: none"> • The remedial works are to correct the current leak and to prevent the leak from recurring. • All repairs are to match the existing for specification and finish and not be apparent as a repair

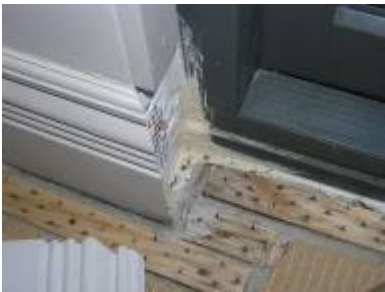
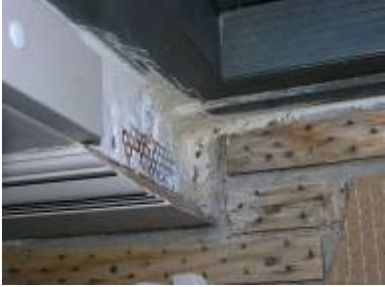
37	<p>Unit 3</p> <p>Description: External water entry in the form of staining and damage to the wall and skirting is evident to the northern elevation side of the lower eastern elevation bedroom sliding door leading out to the yard.</p> <p>It should be noted that a planter box is positioned directly outside this door and abuts the external wall of the bedroom.</p> <p>When tested with a moisture meter, readings in excess of 20% were taken.</p> <p>It was noted that a section of the skirting had been removed and</p>	<p>Allow to carry out the following works:</p> <ul style="list-style-type: none"> • Carry out further tests to accurately determine the precise cause of the water entry. • Carry out all works necessary in order to correct the current leak and to prevent any recurrences. • Make good all original surface finishes affected as part of the remedial works. • Clean up on completion. • P.A of \$12,000.00

Item No	Item Description, Position & Cause	Scope of Works Required	Photograph If Necessary Or Applicable
	<p>bulk sealant had been applied at the base of the door jamb.</p> <p>No further works had been attempted and it was clear from the moisture reading that the water leak is still occurring</p> <p>Cause: Without carrying out destructive exploratory works, an exact cause is unable to be determined at this point of time, however it is considered the cause is a failure and/or defect to the wall cavity flashing and waterproof membrane interface which is allowing moisture to transfer through to the dwelling's internals.</p>	<p>Performance Requirement</p> <ul style="list-style-type: none"> The remedial works are to test, identify and correct the current leak and to prevent the leak from recurring. All repairs are to match the existing for specification and finish and not be apparent as a repair

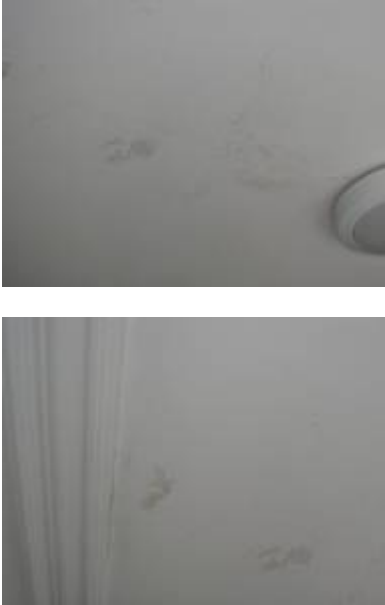
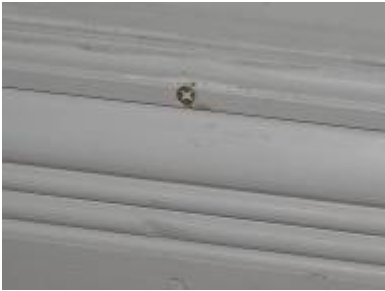
38	<p>Unit 3</p> <p>Description: External water entry is noted in the form of staining and damage to the northern elevation patio soffit directly adjacent to the soffit mounted light.</p> <p>This balcony is directly below the northern elevation balcony for Unit 6.</p> <p>When tested with a moisture meter, readings in excess of 20% were taken.</p> <p>Cause: Without carrying out destructive exploratory works, an exact cause is unable to be determined at this point of time, however it is considered the cause is a failure and or defect to the waterproofing of the northern elevation balcony of Unit 6.</p>	<p>Allow to carry out the following works:</p> <ul style="list-style-type: none"> Strip the tiles, bedding and waterproofing from the northern elevation balcony of Unit 6. Supply and install a new polyurethane waterproof membrane ensuring it is correctly detailed into the balcony door sill flashing and turned down into the drainage points. The membrane is to be turned up the perimeter walls but finished to a height no higher than the skirting tile line Lay a new sand/cement tile bed with correct falls towards the drainage points Apply a secondary membrane over the sand cement screed Supply and install new replacement tiles (PC'd \$40:00 sqm) adhered directly to the tile bed membrane using a compatible adhesive Allow to install all required perimeter and intermediate control joints Allow to paint all perimeter balustrade and external wall using an elastomeric paint colour matched to the original ensuring the paint is run down past and over the line of the

Item No	Item Description, Position & Cause	Scope of Works Required	Photograph If Necessary Or Applicable
		<p>membrane turn up</p> <ul style="list-style-type: none"> • Fix skirting tiles, grout and clean • Carry out minor plaster patching to the moisture effected soffit. • Seal and patch paint the area of repairs • Re-paint the soffit area from shadow line to shadow line using a paint to match the original for specification and finish • Make good all original surface finishes affected as part of the original leak and remedial works. • Clean up on completion. <p>Performance Requirement</p> <ul style="list-style-type: none"> • The remedial works are to correct the current leak and to prevent the leak from recurring. • All repairs are to match the existing for specification and finish and not be apparent as a repair 	
	Unit 4		
39	<p>Description: The skirting boards to the eastern and western elevation walls of the lounge, previously were not fixed soundly to the walls and cracking resulted at the skirting to wall interface.</p> <p>I am instructed the builder had returned to site and carried out some works which included fixing the skirtings back into position via screwing.</p> <p>The builder appears to have rectified the loose fixing of the skirtings, however he has failed to make good the fixing holes and where filler has been used at the junction of the skirting to the wall</p>	<p>Allow to carry out the following works:</p> <ul style="list-style-type: none"> • Fill and cover over the fixing screws with a suitable epoxy style filler. • Sand smooth the filler to achieve a finish flush with the existing skirting matching its profile and plane. • Seal and patch paint the areas of repairs prior to re-painting the entire skirting and wall area from shadow line to shadow line using paints to match the original for specification and finish. • Clean up on completion.
