**SCOPE OF WORKS
&
TENDER DOCUMENT**

The Owners - Strata Plan

Remedial works to Common Property
and within individual unit areas

17th September 2010

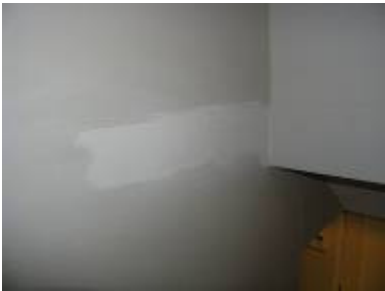
40	<p>Unit 4</p> <p>Description: A horizontal crack and fracturing of the wall render was previously evident to the northern elevation wall of the stairwell.</p> <p>I am instructed the builder had returned to site and carried out some works which included patching and re-plaster setting to the wall.</p> <p>The builder appears to have rectified the original cracking, however he has failed to complete the works by painting over the repairs.</p> <p>Cause: All the works required to correct the original defect and all other consequential damages as a result of the original defect, exploratory and/or remedial works have not been fully completed.</p>	<p>Allow to carry out the following works:</p> <ul style="list-style-type: none"> Sand smooth the existing filler to achieve a finish flush with the existing wall matching its profile and plane. Seal and patch paint the area of repairs prior to re-painting the entire wall area from shadow line to shadow line using paints to match the original for specification and finish. Clean up on completion. <p>Performance Requirement</p> <ul style="list-style-type: none"> The remedial works are to complete partially attended to repairs.

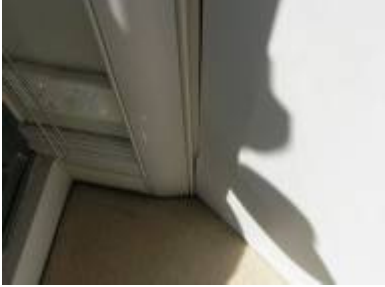
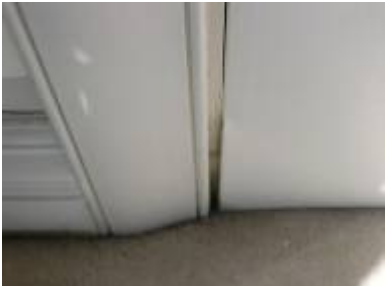
42a	<p>Description: External water entry in the form of staining and damage to the roof cavity void storage area door frame, door and adjoining skirtings.</p> <p>The base of the door has swelled to the point where it will only open to approximately 70deg.</p> <p>I am instructed by the occupant that they first noticed water within the storage area after the most recent heavy rainstorms.</p> <p>They were able to test the area and replicate the leak by pouring water onto the tiled roof externally (positioned to the eastern side of the small balcony area) around the balcony roof support post.</p> <p>As a result of these tests, the occupant has placed large amounts of silicone sealant at the post to roof tile intersection.</p> <p>Water tests carried out during the inspection would appear to confirm the emergency works carried out by the owner have either been successful in stopping the leak or have reduced it to the point where it was not noticeable during the test, but may still be apparent during long term rain.</p> <p>There was no evidence to suggest that works and/or damage had occurred to this area of roof tiling and/or flashing after the initial</p>	<p>Allow to carry out the following works:</p> <ul style="list-style-type: none"> Remove the roof tiles from the small area of roofing around the balcony roof support post. Clean off the occupant installed silicone sealant Inspect the lead flashing, sarking roof tile detailing and make all necessary changes, modifications and or repairs to ensure a waterproof detail Re-fit replacement roof tiles and make good the barge end bedding and pointing Remove and replace the water damaged door jamb and door All new and modified painted surfaces are to be primed and undercoated prior to being repainted to match the original for specification and finish Make good all original surface finishes affected as part of the remedial works. Clean up on completion. <p>Performance Requirement</p>

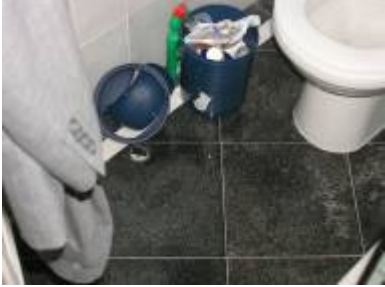
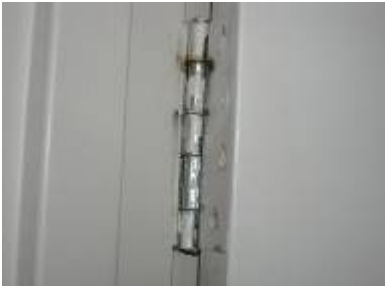
44	<p>Unit 5</p> <p>Description:</p>	<p>Allow to carry out the following works:</p> <ul style="list-style-type: none"> • Supply and install replacement lift off hinges to

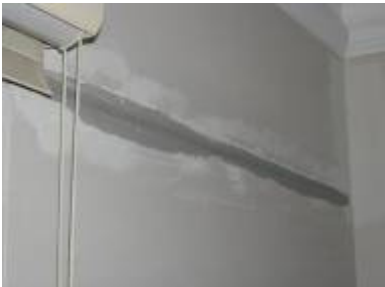
Unit 6		
45	<p>Description: A horizontal crack and fracturing of the wall render was previously evident to the northern elevation wall of the north eastern corner of the bedroom.</p> <p>I am instructed the builder had returned to site and carried out some works which included raking out the delaminated render and re-filling.</p> <p>The builder appears to have rectified the original cracking however he has failed to complete the works by painting over the repairs.</p>	<p>Allow to carry out the following works:</p> <ul style="list-style-type: none"> • Rub down render patching to achieve a finish flush with the existing wall matching its profile and plane. • Seal and patch paint the area of repairs prior to re-painting the entire wall area from shadow line to shadow line using paints to match the original for specification and finish. • Clean up on completion.

Item No	Item Description, Position & Cause	Scope of Works Required	Photograph If Necessary Or Applicable
	<p>Cause: All the works required to correct the original defect and all other consequential damages as a result of the original defect, exploratory and/or remedial works have not been fully completed.</p> <p>I am unable to provide any reason, other than speculation, as to why the builder failed to complete the rectification works.</p>	<p>Performance Requirement</p> <ul style="list-style-type: none"> The remedial works are to complete partially attended to repairs. All repairs are to match the existing for specification and finish and not be apparent as a repair 	
46	<p>Unit 6</p> <p>Description: A vertical crack within the cornice corner joint extending to the cornice to ceiling junction was previously evident to the eastern elevation wall of the kitchen.</p> <p>I am instructed the builder had returned to site and carried out some works which included re-fixing of the cornice and plaster filling of the cracks.</p> <p>The builder appears to have rectified the original cracking however he has failed to complete the works by painting over the repairs</p> <p>Cause: All the works required to correct the original defect and all other consequential damages as a result of the original defect, exploratory and/or remedial works have not been fully completed.</p> <p>I am unable to provide any reason, other than speculation, as to why the builder failed to complete the rectification works.</p>	<p>Allow to carry out the following works:</p> <ul style="list-style-type: none"> Sand smooth the existing filler to achieve a finish flush with the existing cornice matching its profile and plane. Seal and patch paint the area of repairs prior to re-painting the two effected cornice sections from shadow line to shadow line using paints to match the original for specification and finish. Clean up on completion. <p>Performance Requirement</p> <ul style="list-style-type: none"> The remedial works are to complete partially attended to repairs. All repairs are to match the existing for specification and finish and not be apparent as a repair

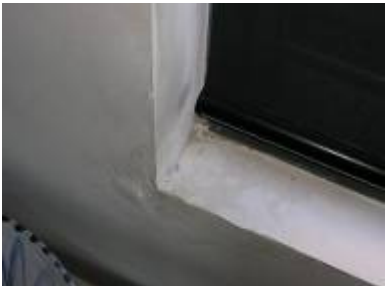
48	<p>Unit 6</p> <p>Description: External water entry in the form of staining and damage to the wall and sill linings are evident beside and below the fixed glass window to the south eastern corner of the lounge.</p> <p>When tested with a moisture meter, readings in excess of 20% were taken.</p> <p>It was noted that some minor paint repairs and touch ups had been carried out along with copious amounts of mastic sealant externally; however the issue regarding the water entry was still to be addressed.</p> <p>Cause:</p>	<p>Allow to carry out the following works:</p> <ul style="list-style-type: none"> Carefully remove and store the window for re-use. Supply and install new sill flashing ensuring correct detailing into the cavity flashing to prevent any water from entering the dwelling. Re-fix the window frame. Seal and patch paint any areas of repairs prior to re-painting from shadow line to shadow line so as to match the existing for specification and finish Make good all original surface finishes affected as part of the remedial works. Clean up on completion.

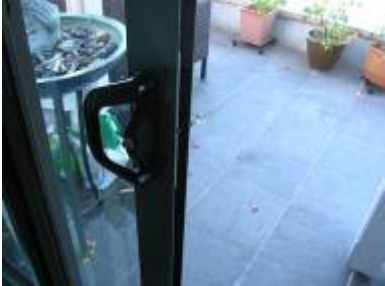
49	<p>Unit 6</p> <p>Description: The sliding door to the upper level southern elevation balcony will not operate with the key and therefore cannot be locked.</p> <p>The key, which fits all other sliding doors, can be inserted and turned, however the lock will not engage.</p> <p>I am instructed the lock has been in this condition since initial handover.</p> <p>This is seriously compromising security for the Unit</p> <p>Cause: Without pulling the lock apart, an exact cause is unable to be</p>	<p>Allow to carry out the following works:</p> <ul style="list-style-type: none"> Locksmith to check lock and make all necessary adjustments and/or repairs to ensure it operates as originally intended. Make good all original surface finishes affected as part of the remedial works. Clean up on completion. <p>Performance Requirement</p> <ul style="list-style-type: none"> The lock is to be modified and repaired so as to ensure it operates as originally intended and a key is supplied

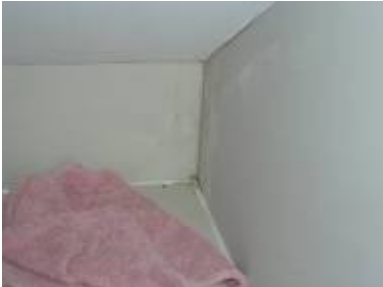
51	<p>Unit 6</p> <p>Description: External water entry in the form of staining and damage to the wall linings within bedroom 1 south western corner over the deck.</p> <p>When tested with a moisture meter, readings in excess of 30% were taken.</p> <p>The area of the leak is directly under the line of the external eastern elevation wall of the southern elevation roof dormer.</p>	<p>Allow to carry out the following works:</p> <ul style="list-style-type: none"> Remove the roof tiles from the area of the dormer. Inspect the lead flashing, sarking roof tile detailing and make all necessary changes, modifications and or repairs to ensure a waterproof detail Carry out minor plaster repairs to the water effected internal surface finishes All new and modified painted surfaces are to be primed and undercoated prior to being re-

Item No	Item Description, Position & Cause	Scope of Works Required	Photograph If Necessary Or Applicable
	<p>I am instructed the builder had previously returned to site and attempted to rectify the leak.</p> <p>The bottom corner weatherboard has been removed (lost) and large amounts of mastic type sealant have been used externally.</p> <p>Cause: Without carrying out destructive exploratory works, an exact cause is unable to be determined at this point of time, however it is considered the cause is issues with the lead soaker flashing and sarking.</p>	<p>painted to match the original for specification and finish</p> <ul style="list-style-type: none"> • Make good all original surface finishes affected as part of the remedial works. • Clean up on completion. <p>Performance Requirement</p> <ul style="list-style-type: none"> • The remedial works are to test, identify and correct the current leak and to prevent the leak from recurring. • All repairs are to match the existing for specification and finish and not be apparent as a repair

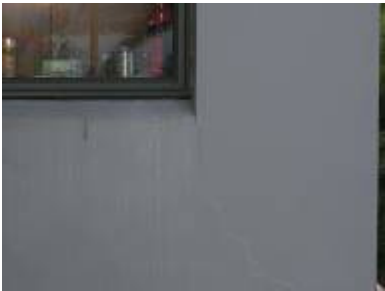
52	<p>Unit 6</p> <p>Description: Vertical cracking and delamination to the wall render is evident to the southern facing external wall under the kitchen window.</p> <p>Due to height and access restrictions, the render either side of the crack was unable to be checked to test the adhesion, however visual evidence such as partially dislodged sections of render along the crack line would indicate that delamination is evident.</p> <p>Cause: The cracking is a result of this section of wall being unable to accommodate the movement experienced within the main structure of the building due to the different rates of movement between the concrete (will shrink) and masonry (will expand) members.</p>	<p>Allow to carry out the following works:</p> <ul style="list-style-type: none"> • Carefully cut and remove the area of delaminated render for a distance of approx 250mm either side of the crack lines. • Treat the base masonry wall with a bonding agent similar to 'Bondcrete'. • If considered necessary, cut and place stainless steel expanded mesh over the crack line to provide some form of reinforcement and resistance to future cracking. • Re-render the area of repair ensuring the render is finished off flush with the adjoining surfaces and with a texture to match the existing. • Seal and patch paint the areas of repair prior to
