**SCOPE OF WORKS
&
TENDER DOCUMENT**

The Owners - Strata Plan

Remedial works to Common Property
and within individual unit areas

17th September 2010

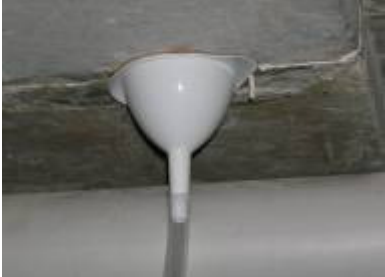
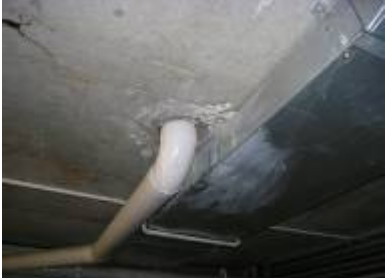
2	<p>Garage:</p> <p>Description: A water leak from the soffit area to the drive is evident just to the northern side of Unit 3's garage door.</p> <p>The water is presently leaking from around a surface water drainage pipe penetration.</p> <p>The location of the leak has calcium hydroxide laden water dripping onto cars manoeuvring within the drive.</p> <p>Cause: The actual cause of the leak is unable to be determined without destructive exploratory works, however it is considered to be due to a failure with the membrane system employed on the slab top to assist with the catching and re-direction of the surface water.</p>	<p>Allow to carry out the following works:</p> <ul style="list-style-type: none"> Supply and install a suitably folded stainless steel soffit gutter under the area of the current leakage fixed to the underside of the concrete soffit using expanding masonry anchors. The gutter is to be specifically manufactured to the required size and shape. The base of the gutter is to be graded to a single drainage position. A 35mm PVC drainage line is to be fitted and sealed to the new soffit gutter. The drainage line is to be fixed to the soffit by adjustable "dropper" style brackets and then run down the nearest masonry wall section to where it is to be cut no more than 50mm from the floor slab to allow for all collected drainage water to run freely to the floor slab. Make good any original finish affected by the remedial works. Clean up on completion. <p>Performance Requirement</p> <ul style="list-style-type: none"> The current soffit leak is to be caught and

Item No	Item Description, Position & Cause	Scope of Works Required	Photograph If Necessary Or Applicable
		<ul style="list-style-type: none"> The current soffit leak is to be caught and directed away to ground where it will cause the least inconvenience to the garage owner and no longer allow for mineral slat contaminated waters to drip on to cars utilizing the garage space

Item No	Item Description, Position & Cause	Scope of Works Required	Photograph If Necessary Or Applicable
		directed away to ground where it will cause the least inconvenience to the garage users and no longer allow for mineral slat contaminated waters to drip on to cars utilizing the garage areas	
	Fire Escape, Western		
3	<p>Description: There is no handrail servicing the stairs leading down into the fire escape from the entry foyer servicing Units 1 & 2.</p> <p>The stairs in their current state pose a safety concern due to there being no suitable place to steady the user in case of a stumble.</p> <p>Cause: The stairs were not constructed correctly in relation to the handrail provisions.</p>	<p>Allow to carry out the following works:</p> <ul style="list-style-type: none"> Supply and install a welded steel handrail along one wall over the stairs. The handrail is to match those used within the remaining areas of the escape for specification and finish. The installation is to comply with the current BCA regulations. Make good any original surface finish affected by the remedial works Clean up on completion. <p>Performance Requirement</p> <ul style="list-style-type: none"> The effected stairs are to have a suitable handrail installed (matching the existing) ensuring compliance is achieved with the BCA provisions for handrail design and installation

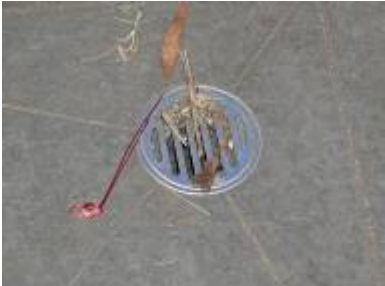
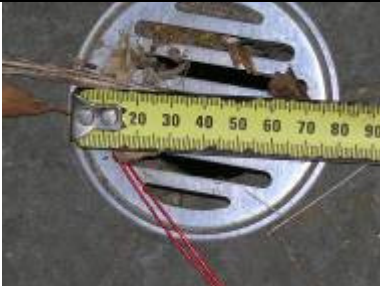
9	<p>External Façade, Northern Elevation</p> <p>Description: The garbage bin enclosure has a tiled floor, is ringed by masonry walls with no drainage and/or overflow provisions and is set lower than the path leading into it, meaning that water which lands or flows into the garbage enclosure can only be removed by the one floor waste.</p> <p>The waste is a single round 75mm grill which can easily be blocked with two or three leaves from the surrounding landscape trees and shrubs.</p> <p>As a result of this easy blockage, I am instructed the garbage room will regularly fill up with approx 100mm of water effectively making it</p>	<p>Allow to carry out the following works:</p> <ul style="list-style-type: none"> Allow to core drill a 75mm diameter hole through one wall of the enclosure at floor level to act as an overflow if and when the floor drain becomes blocked. Ensure the inside face of the core hole is sparged up using a sand/cement mix so as to fill any exposed voids Allow to paint the inside surface of the core hole so as to match the existing walls for specification and finish Make good all original surface finishes affected as part of the remedial works Clean up on completion.

Item No	Item Description, Position & Cause	Scope of Works Required	Photograph If Necessary Or Applicable
	<p>not fit for purpose.</p> <p>Cause: The drainage grate is not suitable for its intended use and position due to its ease of blocking with leaf litter and there is no form of overflow provisions.</p>	<p>Performance Requirement</p> <ul style="list-style-type: none"> The core hole is required to act as an overflow in times where the existing inadequate floor drain is blocked or cannot handle the flow required

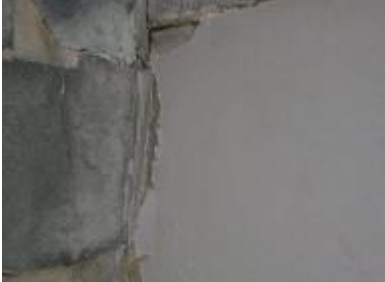
16	<p>External Façade, Western Elevation</p> <p>Description: Vertical cracking and delamination to the wall render is evident to the northern end of the beam over the garage door opening at the interface with the stone faced drive wall.</p> <p>The delamination is affecting the last 20mm of the beam for its full height.</p> <p>Small sections of render have already delaminated and fallen.</p> <p>Cause: The cracking is a result of this section of wall being unable to accommodate the movement experienced between it and the side</p>	<p>Allow to carry out the following works:</p> <ul style="list-style-type: none"> Carefully cut back the render to the beam using a straight vertical line forming an open joint line between the rendered beam and stone faced wall of approx 20mm wide. Tape either side of the open joint line and fill with a colour matched external grade flexible sealant formed to be a control joint line. Seal and patch paint the areas of repair prior to re-painting the affected areas from shadow line to shadow line. Clean up on completion. <p>Performance Requirement</p>

Item No	Item Description, Position & Cause	Scope of Works Required	Photograph If Necessary Or Applicable
	<p>drive wall at the interface.</p> <p>Without adequate precautions such as functioning slip and control joints, uncontrolled cracking will be the result.</p>	<ul style="list-style-type: none"> The area of failed render is to be removed and replaced and on completion the wall is not to appear to have been patch repaired

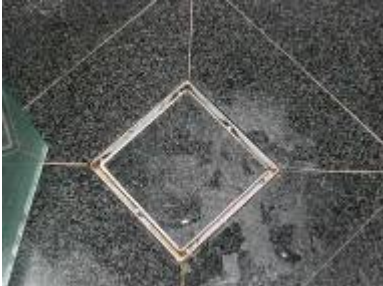
Item No	Item Description, Position & Cause	Scope of Works Required	Photograph If Necessary Or Applicable
	I am unable to provide any reason other than speculation as to why the builder failed to complete the rectification works.		
23	<p>Unit 1</p> <p>Description: The grout used to bedroom 1 ensuite floor tiles around the concealed architectural floor waste to both the main floor and shower recess areas is breaking up, losing adhesion and coming out from within the joint line between the tile edge and outer aluminium frame of the waste.</p> <p>Cause: The failure of the grout is due to the minimal thickness (less than 2mm) and the extent of thermal expansion and contraction which will occur to the waste frame.</p> <p>The minimal thickness of the grout will not allow for the expected movement and has therefore cracked and failed.</p> <p>A flexible polysulphide based sealant should have been used at the junction of the tiles and waste frame instead of a hard cement based grout.</p>	<p>Allow to carry out the following works:</p> <ul style="list-style-type: none"> • Rake out the existing failed hard grout from between the granite floor tiles and floor waste frame of the ensuite floor and shower recess areas. • Tape either side of the joint lines and fill with a colour matched polysulphide based sealant finished with a concave upper face. • Remove the tape prior to the sealant setting. • Clean up on completion. <p>Performance Requirement</p> <ul style="list-style-type: none"> • The failed area of grout is to be removed and replaced with a colour matched flexible sealant

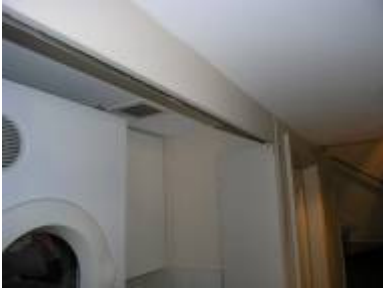
Item No	Item Description, Position & Cause	Scope of Works Required	Photograph If Necessary Or Applicable
	base of the concealed powder room WC and that this is now tracking through to the ensuite instead of the linen closet as before.		
30	<p>Unit 1</p> <p>Description: The bi-fold doors to the lower level laundry alcove have failed and fallen off due to fixings pulling from the doors etc.</p> <p>There is no evidence to suggest the failure is due to misuse by the occupant as the Unit is maintained to a very high quality standard.</p> <p>Cause: It is considered the tracks and fittings used for the laundry were not suitable for use with heavy doors and as such they have failed with constant use.</p>	<p>Allow to carry out the following works:</p> <ul style="list-style-type: none"> Remove the existing track and doors. Make all necessary repairs and re-fix the track ensuring the components used are suitable for the type, size and weight of doors to be used. Make good all original surface finishes affected as part of the remedial works. Clean up on completion. <p>Performance Requirement</p> <ul style="list-style-type: none"> The track fittings and fixtures are to modified/replaced to the point the doors will operate as originally intended

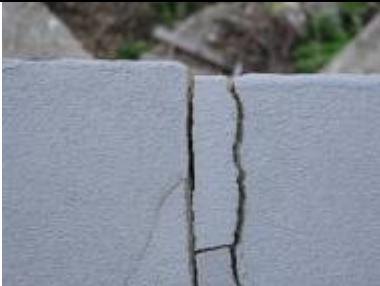
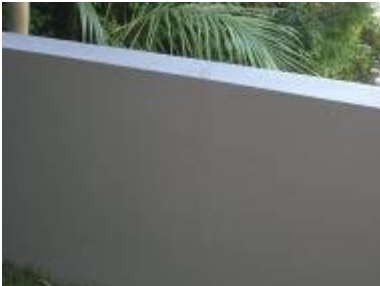
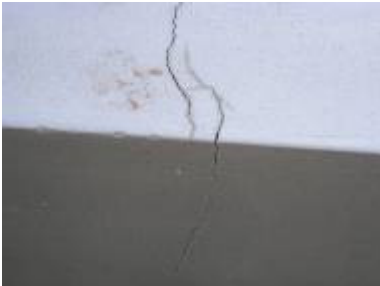
31	<p>Unit 1</p> <p>Description: Vertical cracking to the southern elevation yard retaining wall was evident to the following areas:</p> <ul style="list-style-type: none"> Cracking of up to 5mm in width to the angled section of wall to the south western corner. Cracking of up to 1.5mm in width to the southern section of wall at approx mid span. <p>The render either side of the crack was checked and found to be emitting a drummy noise indicating loss of adhesion with the base wall.</p> <p>Cause:</p>	<p>Allow to carry out the following works:</p> <ul style="list-style-type: none"> Allow to diamond saw cut the render for a distance of approx 1000mm either side of the existing crack line Remove the render back to the base masonry Supply and fix stainless steel Heli-fix bars across the crack line in accordance with the manufacturers recommendations Supply and fix stainless steel expanded mesh over the exposed masonry area Allow to re-render the area using a 6:1:1 mix ensuring the new render is finished off flush with all adjoining surfaces and matches the original for texture and profile.

Item No	Item Description, Position & Cause	Scope of Works Required	Photograph If Necessary Or Applicable
	<p>The cracking is a result of this section of wall being unable to accommodate the movement experienced.</p> <p>Without adequate precautions such as functioning slip and control joints, uncontrolled cracking will be the result.</p>	<ul style="list-style-type: none"> Seal and patch paint the areas of repair prior to re-painting the affected wall areas from shadow line to shadow line. Make good all original surface finishes affected as part of the remedial works Clean up on completion. <p>Performance Requirement</p> <ul style="list-style-type: none"> The area of cracked render is to be removed and replaced, the wall stitched and on completion the wall is not to appear to have been patch repaired in that the finish is to be uniform

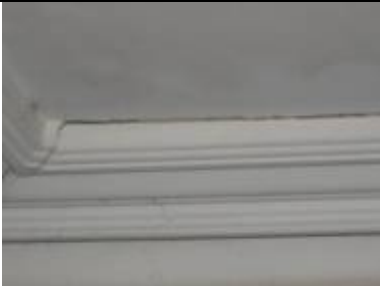
Item No	Item Description, Position & Cause	Scope of Works Required	Photograph If Necessary Or Applicable
	<p>concrete (will shrink) and masonry (will expand) members.</p> <p>Without adequate precautions such as functioning slip and control joints, uncontrolled cracking will be the result.</p>	<p>specification and finish.</p> <ul style="list-style-type: none"> Clean up on completion. <p>Performance Requirement</p> <ul style="list-style-type: none"> The cornice is to be soundly fixed into position and damage caused by the previous repair attempts fully rectified. The ceiling and cornice is are to be repainted and show no indication of repairs

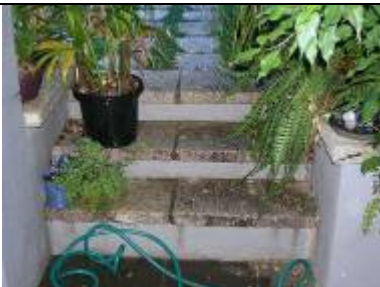
34	<p>Unit 2</p> <p>Description:</p> <p>There is no handrail servicing the three riser stair flight leading from the bed 1 covered patio area up to the grassed courtyard.</p> <p>The stairs in their current state pose a safety concern due to there being no suitable place to steady the user in case of a stumble.</p> <p>Cause:</p> <p>The stairs were not constructed correctly in relation to the handrail provisions.</p>	<p>Allow to carry out the following works:</p> <ul style="list-style-type: none"> Supply and install a handrail to one side over the set of stairs. The handrail is to match those used in other external areas of the development or be sympathetic to the design and quality of the materials used as well as being suitable for a marine environment. The installation is to comply with the current BCA regulations. Make good any original finish affected as apart of the remedial works Clean up on completion <p>Performance Requirement</p> <ul style="list-style-type: none"> The effected stairs are to have a suitable handrail installed (matching the existing) ensuring compliance is achieved with the BCA provisions for handrail design and installation

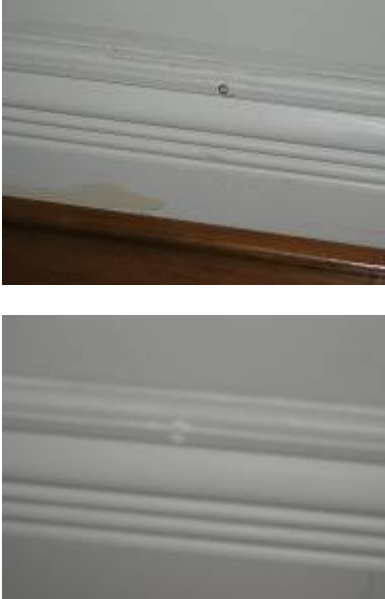
Item No	Item Description, Position & Cause	Scope of Works Required	Photograph If Necessary Or Applicable
	<p>Cause: All the works required to correct the original defect and all other consequential damages as a result of the original defect, exploratory and/or remedial works have not been fully completed. I am unable to provide any reason other than speculation as to why the builder failed to complete the rectification works.</p>	<p>Performance Requirement</p> <ul style="list-style-type: none"> The remedial works are to cover over the existing poorly finished mechanical fixings for the skirting. All repairs are to match the existing for specification and finish and not be apparent as a repair

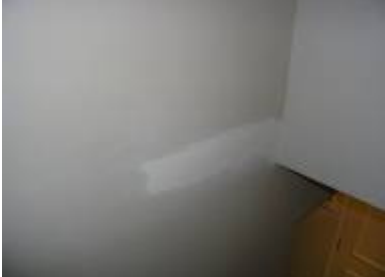
40	<p>Unit 4</p> <p>Description: A horizontal crack and fracturing of the wall render was previously evident to the northern elevation wall of the stairwell.</p> <p>I am instructed the builder had returned to site and carried out some works which included patching and re-plaster setting to the wall.</p> <p>The builder appears to have rectified the original cracking, however he has failed to complete the works by painting over the repairs.</p> <p>Cause: All the works required to correct the original defect and all other consequential damages as a result of the original defect, exploratory and/or remedial works have not been fully completed.</p>	<p>Allow to carry out the following works:</p> <ul style="list-style-type: none"> Sand smooth the existing filler to achieve a finish flush with the existing wall matching its profile and plane. Seal and patch paint the area of repairs prior to re-painting the entire wall area from shadow line to shadow line using paints to match the original for specification and finish. Clean up on completion. <p>Performance Requirement</p> <ul style="list-style-type: none"> The remedial works are to complete partially attended to repairs.

Item No	Item Description, Position & Cause	Scope of Works Required	Photograph If Necessary Or Applicable
	I am unable to provide any reason other than speculation as to why the builder failed to complete the rectification works.	<ul style="list-style-type: none"> All repairs are to match the existing for specification and finish and not be apparent as a repair

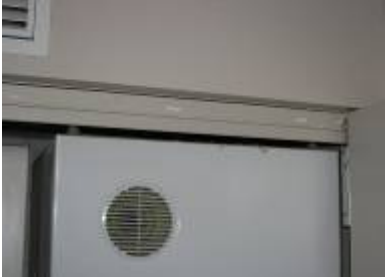
41	<p>Unit 4</p> <p>Description: The head track for the upper level laundry alcove bi-fold doors are not securely fixed to the head and are therefore creating a gap of up to 2mm between the head track and timber reveal.</p> <p>The deflection of the track is affecting the operation of the doors to the point where they are difficult to open and close.</p> <p>There is no evidence to suggest the failure is due to misuse by the occupant as the Unit is maintained to a very high quality standard.</p> <p>Cause: It is considered the tracks and fixings used for the laundry were not suitable for use with heavy doors and as such they have failed with constant use.</p>	<p>Allow to carry out the following works:</p> <ul style="list-style-type: none"> Remove the existing track and doors. Make all necessary repairs and re-fix the track ensuring the components used are suitable for the type, size and weight of doors to be used. Make good all original surface finishes affected as part of the remedial works. Clean up on completion. <p>Performance Requirement</p> <ul style="list-style-type: none"> The track fittings and fixtures are to modified/replaced to the point the doors will operate as originally intended

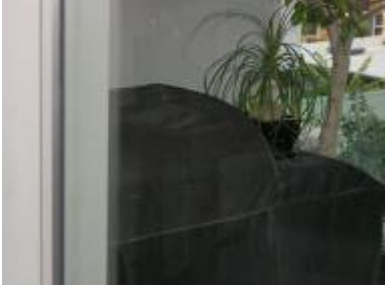
42	<p>Unit 4</p> <p>Description: The glass panel to the east side sliding door within the lounge southern elevation has a stain within the glass which takes on the appearance of shading.</p> <p>The stained area of glass was vigorously scrubbed with glass cleaner on both sides of the glass so as to confirm the staining is</p>	<p>Allow to carry out the following works:</p> <ul style="list-style-type: none"> Glazier to remove and replace the flawed section of glass within the door frame. Make good all original surface finishes affected as part of the remedial works. Clean up on completion.

Item No	Item Description, Position & Cause	Scope of Works Required	Photograph If Necessary Or Applicable
	<p>within the glass.</p> <p>This visual item is clearly evident during daylight hours and as this is a picture window with views down the harbour the occupant has the windows very clean and as such the stain becomes more obvious.</p> <p>Cause: It is considered the glass section was faulty from the factory.</p>	<p>Performance Requirement</p> <ul style="list-style-type: none"> The flawed pane of glass is to be removed and replaced with a pane of glass that matches the original for specification and finish but is clear without flaws or blemishes

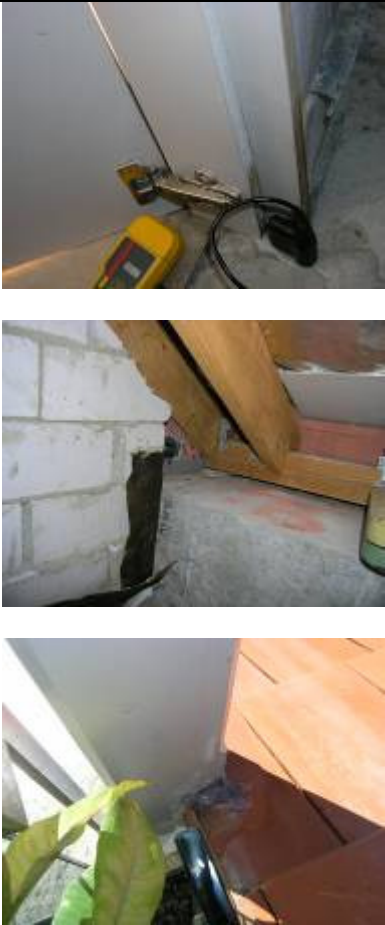
42a	<p>Description: External water entry in the form of staining and damage to the roof cavity void storage area door frame, door and adjoining skirtings.</p> <p>The base of the door has swelled to the point where it will only open to approximately 70deg.</p> <p>I am instructed by the occupant that they first noticed water within the storage area after the most recent heavy rainstorms.</p> <p>They were able to test the area and replicate the leak by pouring water onto the tiled roof externally (positioned to the eastern side of the small balcony area) around the balcony roof support post.</p> <p>As a result of these tests, the occupant has placed large amounts of silicone sealant at the post to roof tile intersection.</p> <p>Water tests carried out during the inspection would appear to confirm the emergency works carried out by the owner have either been successful in stopping the leak or have reduced it to the point where it was not noticeable during the test, but may still be apparent during long term rain.</p> <p>There was no evidence to suggest that works and/or damage had occurred to this area of roof tiling and/or flashing after the initial</p>	<p>Allow to carry out the following works:</p> <ul style="list-style-type: none"> Remove the roof tiles from the small area of roofing around the balcony roof support post. Clean off the occupant installed silicone sealant Inspect the lead flashing, sarking roof tile detailing and make all necessary changes, modifications and or repairs to ensure a waterproof detail Re-fit replacement roof tiles and make good the barge end bedding and pointing Remove and replace the water damaged door jamb and door All new and modified painted surfaces are to be primed and undercoated prior to being repainted to match the original for specification and finish Make good all original surface finishes affected as part of the remedial works. Clean up on completion. <p>Performance Requirement</p>

Item No	Item Description, Position & Cause	Scope of Works Required	Photograph If Necessary Or Applicable
	<p>contracted works had been completed.</p> <p>When the areas of water damage were tested with a moisture meter, the readings were all around the 12% region which is considered to be dry.</p> <p>It is considered the dry readings are as a result of the occupant actively taking measures to temporarily stop the leak and to dry out the storage area</p> <p>Cause: Without carrying out destructive exploratory works, (lifting tiles will affect the barge bedding and pointing) an exact cause is unable to be determined at this point in time, however it is considered the cause is defective lead flashing installation around the balcony roof support post allowing water to enter into the roof cavity storage area.</p>	<ul style="list-style-type: none"> The remedial works are to test, identify and correct the current leak and to prevent the leak from recurring. All repairs are to match the existing for specification and finish and not be apparent as a repair

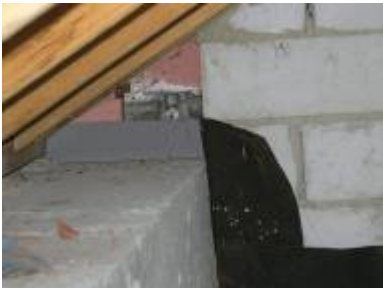
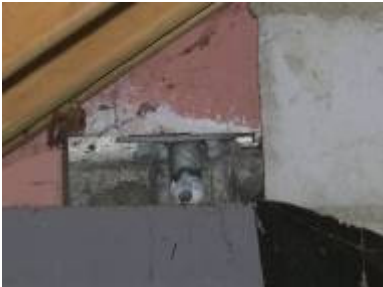
Unit 5		
43	<p>Description: There is direct access for vermin within the north eastern corner area eaves lines.</p> <p>When viewing from within the roof cavity storage area, clear access measuring approx 120mm x 40mm is available from external to internal which will allow vermin to enter.</p> <p>Cause: The detailing of the eaves linings was not correctly carried out so as to ensure the roof area was adequately sealed and gaps kept to a minimum.</p>	<p>Allow to carry out the following works:</p> <ul style="list-style-type: none"> • Fill the open hole with expanding foam ensuring adequate precautions are taken to prevent the foam from spilling over externally and becoming a further visual defect. • Make good all original surface finishes affected as part of the remedial works. • Clean up on completion. <p>Performance Requirement</p> <ul style="list-style-type: none"> • The excessive sized access hole through the external envelope is to be permanently filled so as to prevent vermin entry

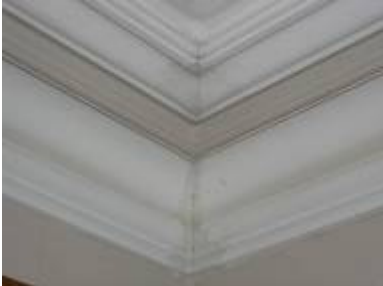
Item No	Item Description, Position & Cause	Scope of Works Required	Photograph If Necessary Or Applicable
	<p>Cause: All the works required to correct the original defect and all other consequential damages as a result of the original defect, exploratory and/or remedial works have not been fully completed.</p> <p>I am unable to provide any reason, other than speculation, as to why the builder failed to complete the rectification works.</p>	<p>Performance Requirement</p> <ul style="list-style-type: none"> The remedial works are to complete partially attended to repairs. All repairs are to match the existing for specification and finish and not be apparent as a repair 	
46	<p>Unit 6</p> <p>Description: A vertical crack within the cornice corner joint extending to the cornice to ceiling junction was previously evident to the eastern elevation wall of the kitchen.</p> <p>I am instructed the builder had returned to site and carried out some works which included re-fixing of the cornice and plaster filling of the cracks.</p> <p>The builder appears to have rectified the original cracking however he has failed to complete the works by painting over the repairs</p> <p>Cause: All the works required to correct the original defect and all other consequential damages as a result of the original defect, exploratory and/or remedial works have not been fully completed.</p> <p>I am unable to provide any reason, other than speculation, as to why the builder failed to complete the rectification works.</p>	<p>Allow to carry out the following works:</p> <ul style="list-style-type: none"> Sand smooth the existing filler to achieve a finish flush with the existing cornice matching its profile and plane. Seal and patch paint the area of repairs prior to re-painting the two effected cornice sections from shadow line to shadow line using paints to match the original for specification and finish. Clean up on completion. <p>Performance Requirement</p> <ul style="list-style-type: none"> The remedial works are to complete partially attended to repairs. All repairs are to match the existing for specification and finish and not be apparent as a repair

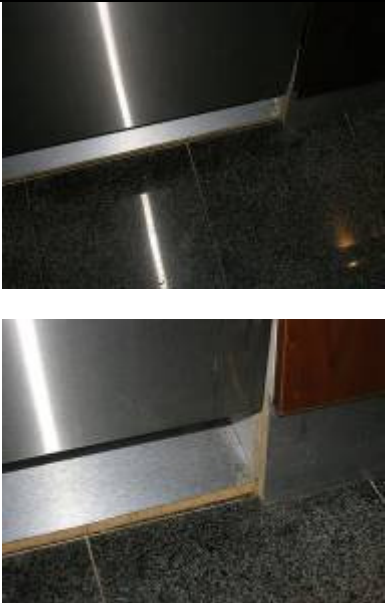
47	<p>Unit 6</p> <p>Description: The stainless steel faced kickboard section in front of the dishwasher had originally been removed by the builder due to a</p>	<p>Allow to carry out the following works:</p> <ul style="list-style-type: none"> Supply and install concealed fixing for the replacement section of kickboard to ensure it remains solidly fixed, is in line with the original

Item No	Item Description, Position & Cause	Scope of Works Required	Photograph If Necessary Or Applicable
	<p>delamination issue but the replacement item had not been supplied.</p> <p>I am instructed the builder had returned to site, supplied and installed a new kickboard section; however this new section is not solidly fixed into position and will get knocked back out of alignment with the slightest touch.</p> <p>Cause: All the works required to correct the original defect such as fixing of the replacement section have not been fully completed.</p> <p>I am unable to provide any reason, other than speculation, as to why the builder failed to complete the rectification works.</p>	<p>kickboards and can easily be removed without damage.</p> <ul style="list-style-type: none"> Clean up on completion. <p>Performance Requirement</p> <ul style="list-style-type: none"> The kickboard is to be fixed back into position, however it is to allow for quick and easy removal for dishwasher servicing when required without damaging the kickboard or dishwasher

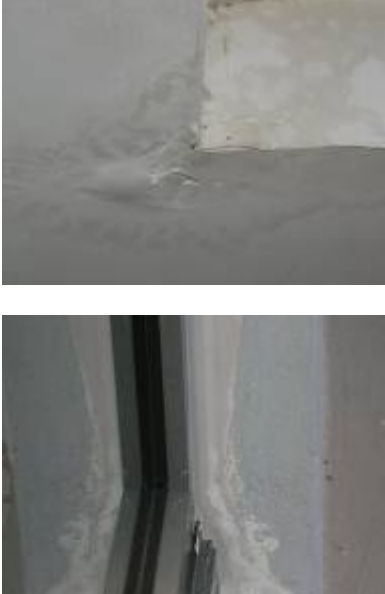
48	<p>Unit 6</p> <p>Description: External water entry in the form of staining and damage to the wall and sill linings are evident beside and below the fixed glass window to the south eastern corner of the lounge.</p> <p>When tested with a moisture meter, readings in excess of 20% were taken.</p> <p>It was noted that some minor paint repairs and touch ups had been carried out along with copious amounts of mastic sealant externally; however the issue regarding the water entry was still to be addressed.</p> <p>Cause:</p>	<p>Allow to carry out the following works:</p> <ul style="list-style-type: none"> Carefully remove and store the window for re-use. Supply and install new sill flashing ensuring correct detailing into the cavity flashing to prevent any water from entering the dwelling. Re-fix the window frame. Seal and patch paint any areas of repairs prior to re-painting from shadow line to shadow line so as to match the existing for specification and finish Make good all original surface finishes affected as part of the remedial works. Clean up on completion.

Item No	Item Description, Position & Cause	Scope of Works Required	Photograph If Necessary Or Applicable
	<p>Without carrying out destructive exploratory works, an exact cause is unable to be determined at this point of time, however it is considered the cause is either missing or incorrectly installed sill flashing. water entry.</p>	<p>Performance Requirement</p> <ul style="list-style-type: none"> The remedial works are to correct the current leak and to prevent the leak from recurring. All repairs are to match the existing for specification and finish and not be apparent as a repair

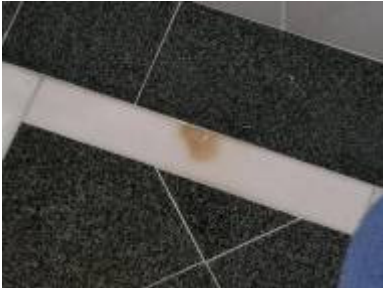
Item No	Item Description, Position & Cause	Scope of Works Required	Photograph If Necessary Or Applicable
	determined at this point of time, however it is considered the lock was most likely faulty at the time of installation.		
50	<p>Unit 6</p> <p>Description: Corrosion type staining is evident within the marble border tile on the floor to the western side of the ensuite bathroom.</p> <p>The staining is affecting one tile only and appears to be leaching into the tile from the bed underneath.</p> <p>Cause: Without destructive exploratory works a precise cause is unable to be determined, however it is considered to have been caused by a nail or small piece of ferrous steel contaminate being within the floor tile bedding and the staining is leaching up the rear of the border tile by capillary action.</p>	<p>Allow to carry out the following works:</p> <ul style="list-style-type: none"> Remove the affected border tiles and closest floor tile ensuring the existing waterproofing arrangements are left undamaged and/or are repaired. Identify and remove the corrosion affected tile bedding including the cause. Supply and lay new floor and wall tiles finished off to match the existing. Make good all original surface finishes affected as part of the remedial works. Clean up on completion. <p>Performance Requirement</p> <ul style="list-style-type: none"> The corrosion stained tile is to be removed and replaced whilst leaving a finish to where repairs are not evident

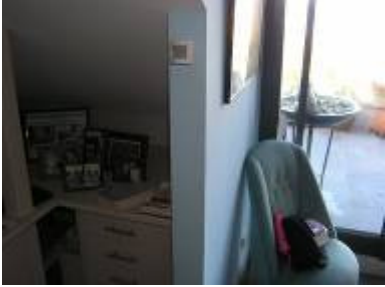
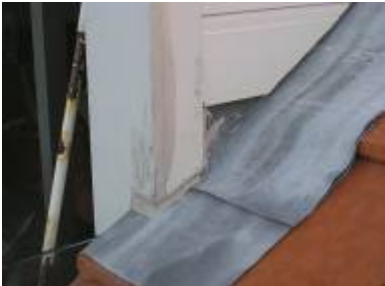
Item No	Item Description, Position & Cause	Scope of Works Required	Photograph If Necessary Or Applicable
	<p>I am instructed the builder had previously returned to site and attempted to rectify the leak.</p> <p>The bottom corner weatherboard has been removed (lost) and large amounts of mastic type sealant have been used externally.</p> <p>Cause: Without carrying out destructive exploratory works, an exact cause is unable to be determined at this point of time, however it is considered the cause is issues with the lead soaker flashing and sarking.</p>	<p>painted to match the original for specification and finish</p> <ul style="list-style-type: none"> • Make good all original surface finishes affected as part of the remedial works. • Clean up on completion. <p>Performance Requirement</p> <ul style="list-style-type: none"> • The remedial works are to test, identify and correct the current leak and to prevent the leak from recurring. • All repairs are to match the existing for specification and finish and not be apparent as a repair

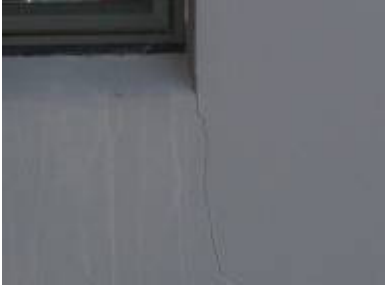
52	<p>Unit 6</p> <p>Description: Vertical cracking and delamination to the wall render is evident to the southern facing external wall under the kitchen window.</p> <p>Due to height and access restrictions, the render either side of the crack was unable to be checked to test the adhesion, however visual evidence such as partially dislodged sections of render along the crack line would indicate that delamination is evident.</p> <p>Cause: The cracking is a result of this section of wall being unable to accommodate the movement experienced within the main structure of the building due to the different rates of movement between the concrete (will shrink) and masonry (will expand) members.</p>	<p>Allow to carry out the following works:</p> <ul style="list-style-type: none"> • Carefully cut and remove the area of delaminated render for a distance of approx 250mm either side of the crack lines. • Treat the base masonry wall with a bonding agent similar to 'Bondcrete'. • If considered necessary, cut and place stainless steel expanded mesh over the crack line to provide some form of reinforcement and resistance to future cracking. • Re-render the area of repair ensuring the render is finished off flush with the adjoining surfaces and with a texture to match the existing. • Seal and patch paint the areas of repair prior to

Item No	Item Description, Position & Cause	Scope of Works Required	Photograph If Necessary Or Applicable
	Without adequate precautions such as functioning slip and control joints, uncontrolled cracking will be the result.	<p>re-painting the affected areas from shadow line to shadow line.</p> <ul style="list-style-type: none"> • Clean up on completion. <p>Performance Requirement</p> <ul style="list-style-type: none"> • The area of cracked render is to be removed and replaced and on completion the wall is not to appear to have been patch repaired in that the finish is to be uniform
